ENHANCING LAST MILE CONNECTIVITY

a safety analysis of the Khan Market Metro Station

This Report has been prepared as part of the Project being undertaken with NDMC to Enhance the Last Mile Connectivity along the metro stations within its jurisdiction. The safety audits were conducted by Smt. Bhagwati Bisht, architect from NDMC along with Safetipin team.

Khan Market

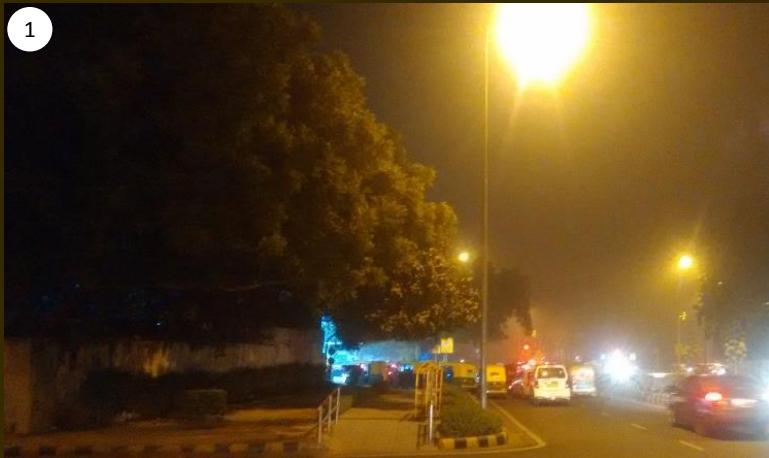
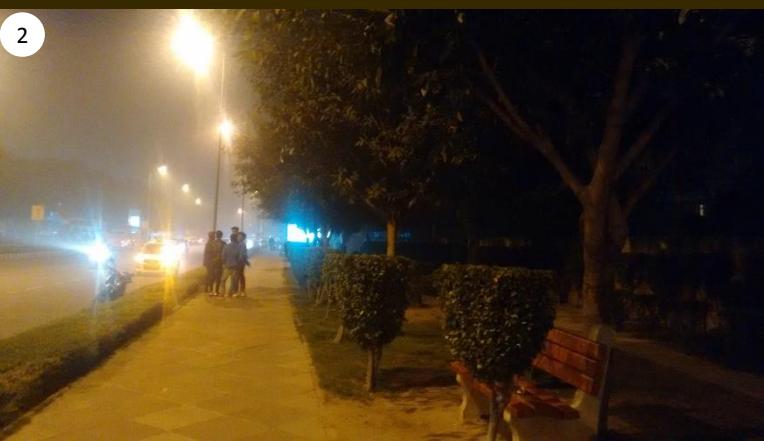
As seen in pic 1 and 2, the streetlights are installed facing the vehicular carriageway resulting in brightly lit road and footpath. However, at some points due to shadows cast by the trees on the footpath, it results in poorly lit spaces along the boundary wall. Seen in pic 2, while the illumination on the footpath is adequate, the green belt equipped with seating along the boundary wall is poorly lit. Pedestrian scale streetlights need to be installed along the boundary wall to ensure uniform illumination.

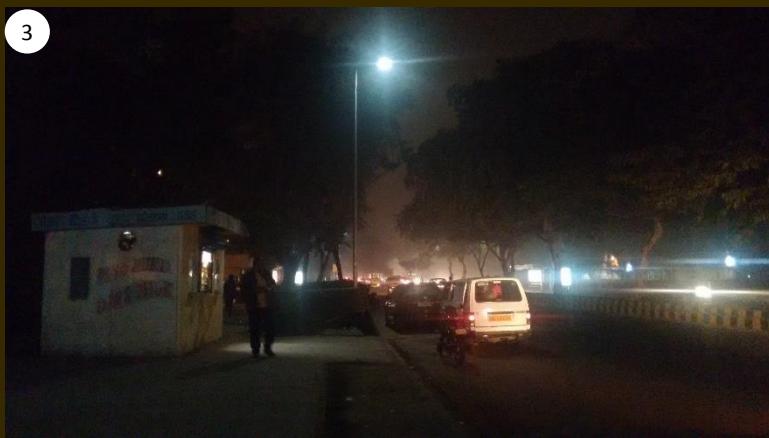
On Maharishi Raman Marg as seen in pic 3, the spread of LED lights is inadequate. As a result, both road and footpath are poorly lit. In order to improve lighting, the Lux level of the streetlights facing the main road should be increased. Additionally, pedestrian scale lighting should be installed facing the footpath.

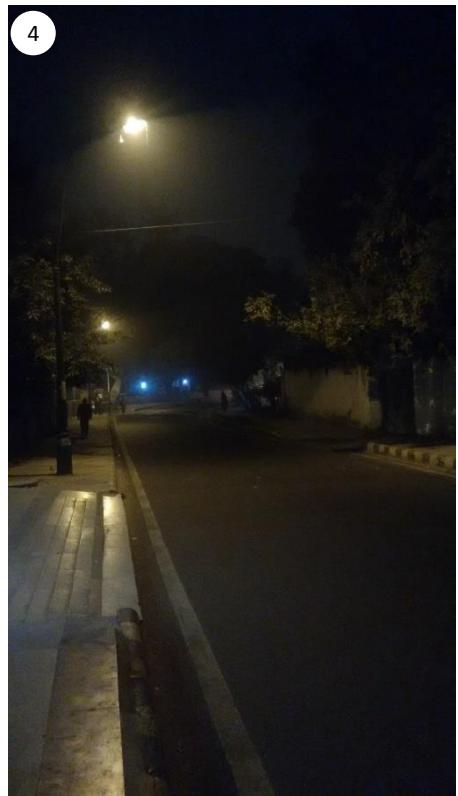
Along neighbourhood roads, streetlights are present on one side of the road (pic4). They are not adequate as the other side of the road is poorly lit. In such lanes, streetlights should be installed alternately on both sides of the road along the boundary wall.

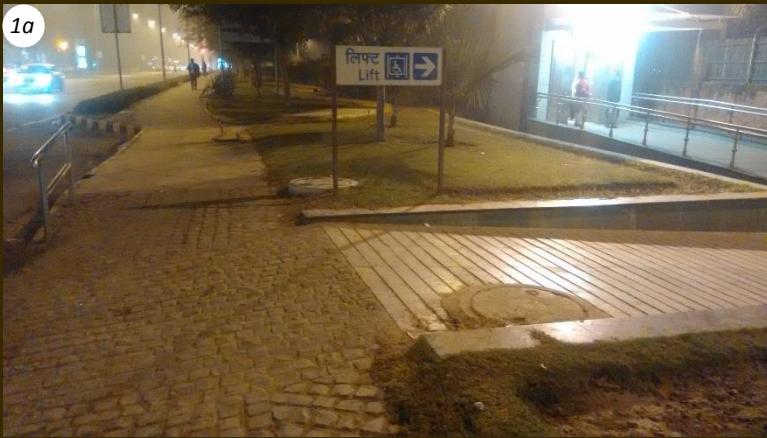
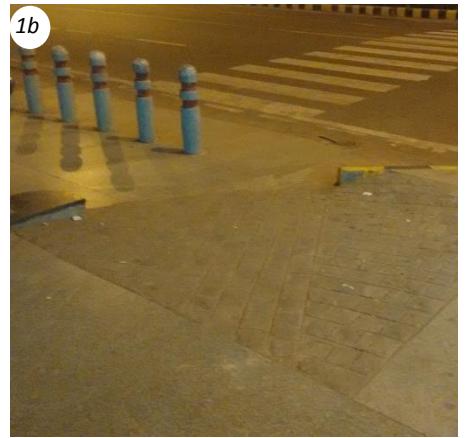
Though the footpath is well maintained throughout the audit area, the ramp and bollards provided for the physically challenged are not easily accessible. Handrails should be provided at the edge of the ramp (pic 1a). Also as seen in pic 1b, the ramp provided is not proper and its edges can prove risky for people on wheelchair. The ramp should be clear of any obstruction and should have a gradual slope. The spacing between the bollards should be such that it is accessible by the physically challenged. Additionally, tactile paving should be provided throughout on the footpath for the visually challenged.

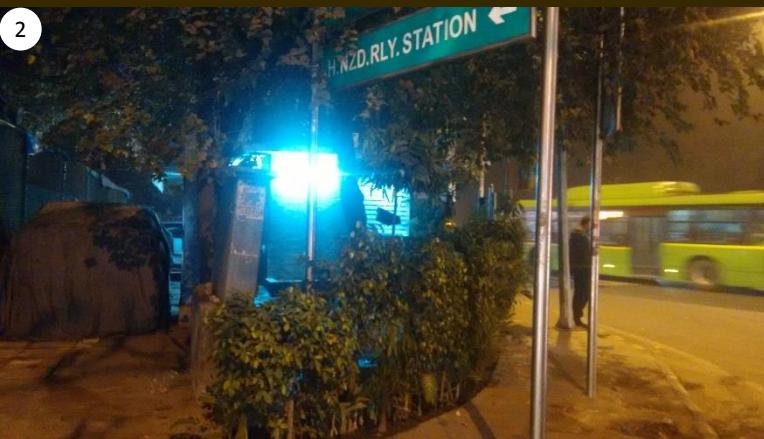
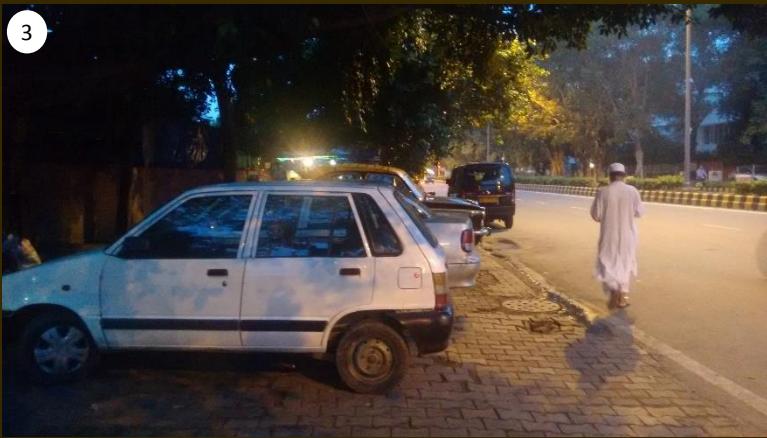
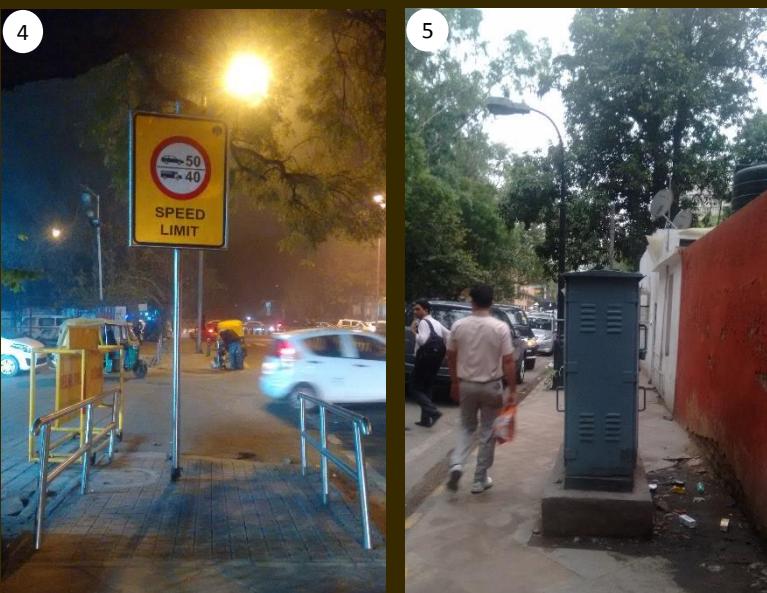
As seen in pic 2 and 3, vehicles have obstructed the walkpath. Seen in pic 2, a taxi stand has been set up on the footpath and has marked its edges using shrubs. To reclaim the footpath for the pedestrians, the space currently used for parking should be cleared for the pedestrians. Separate space should be provided for vehicular parking, clear of the footpath. Similarly, as seen in pic 3 parking should be disallowed on the walkpath and a proper footpath should be constructed, raised at a level, clear of any obstruction. Various obstructions found in the audit area include electrical unit, banners, signage etc. Seen in pic 4 and 5, the sign board and electrical units should be placed along the edge of the footpath, clear of the pedestrian path.

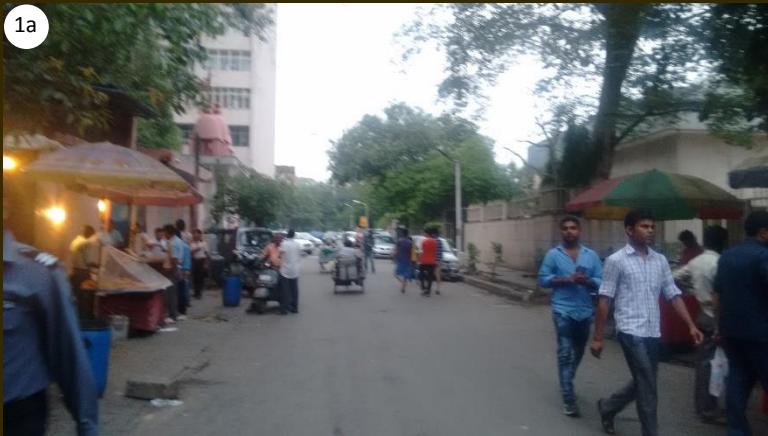
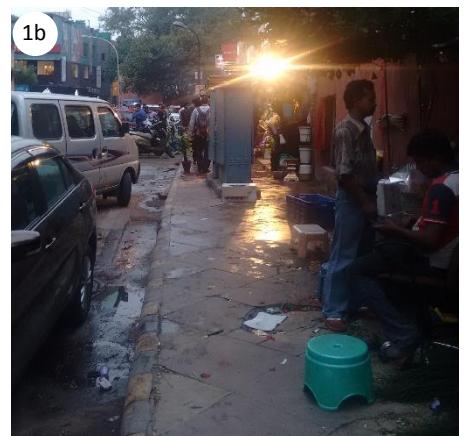
As seen in Pic 1a and 1b, street vendors present near Khan Market occupy the walkpath. A designated space should be created for these hawkers, clear of the footpath. In Pic 1a, the hawkers can be shifted to one side, leaving the footpath on the other side free for the commuters.

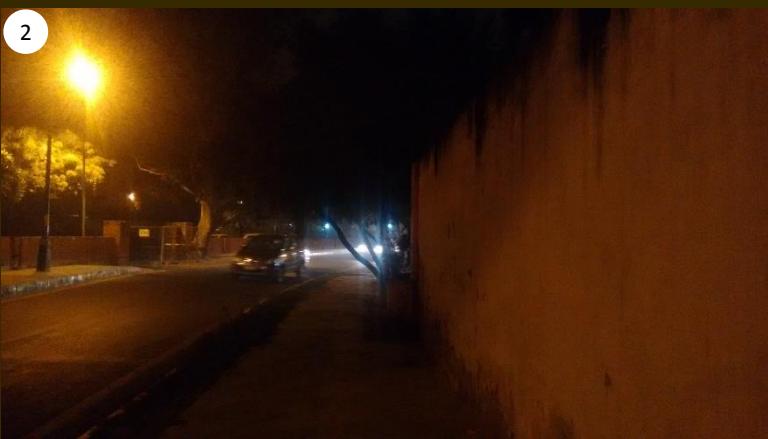
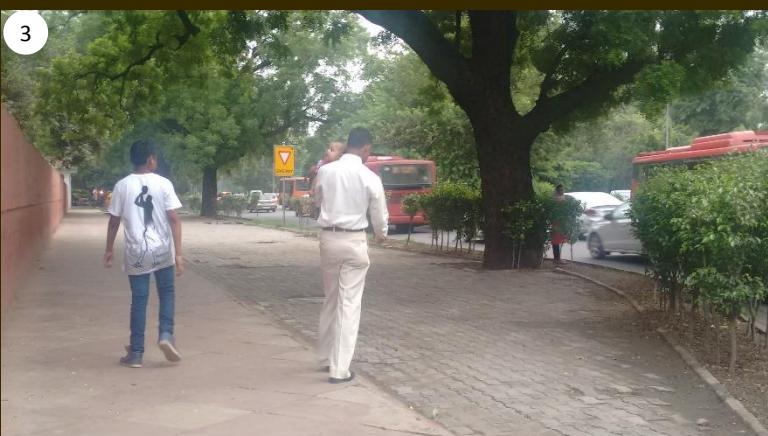
Inactive edges and high boundary walls as seen in pic 2 and 3, results in poor visibility on the footpath. The height of the opaque part of the boundary wall should be maintained at 1m. The rest of the height can be attained using grills. The pavement as seen in pic 3 is wide enough to accommodate street furniture and street vendors. These additions can help in making this area active.

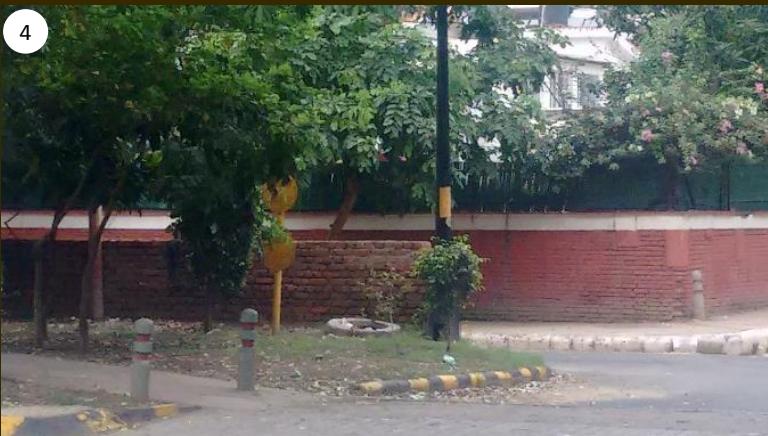
In residential neighbourhood as seen in pic 4, the solid part of the boundary wall is low and the rest of the wall is made opaque using wooden fence. To improve visibility, this wooden fence should be taken down and can be replaced with grills. Also, the edge of the service lane is defined by a low height brick wall. This wall acts as a unnecessary barrier between the service lane and the footpath. The wall should be taken down to provide some visibility and smooth movement for the pedestrians.

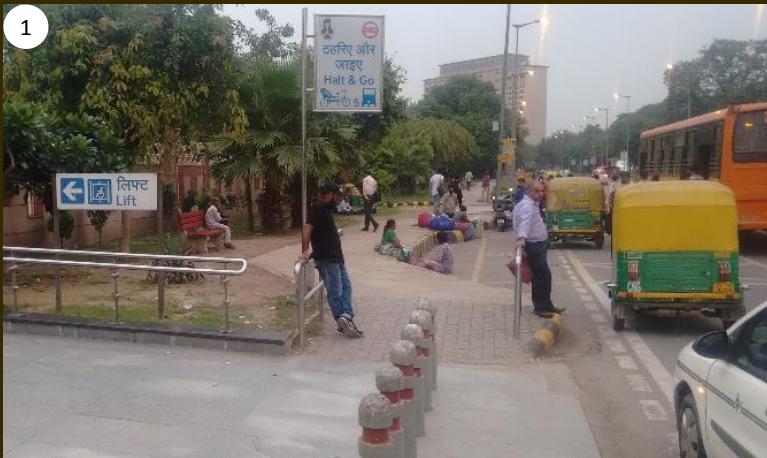
As seen in pic 1, there is a designated para transit stand outside the metro station. People are seen squatting on the pavement as existing seating furniture is not adequate. Additional street furniture should be provided for the commuters.

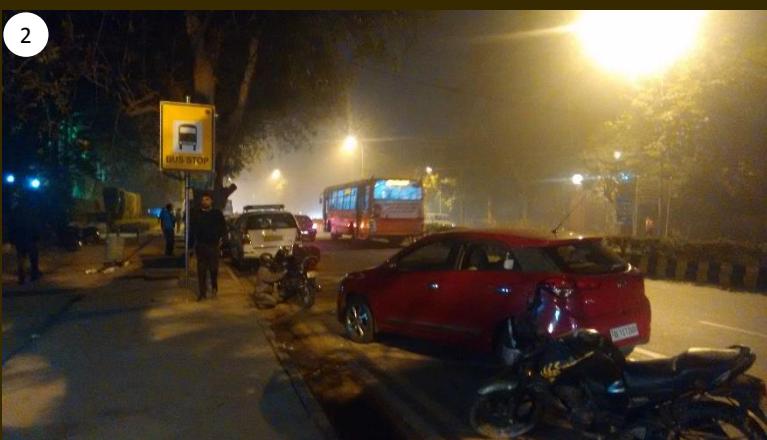
As seen in pic 2, bus stop is identified through the sign board on the footpath and it has no shelter for people. The space left for the bus is occupied by vehicles. A bus shelter should be provided and vehicular parking should be disallowed on the main carriageway.

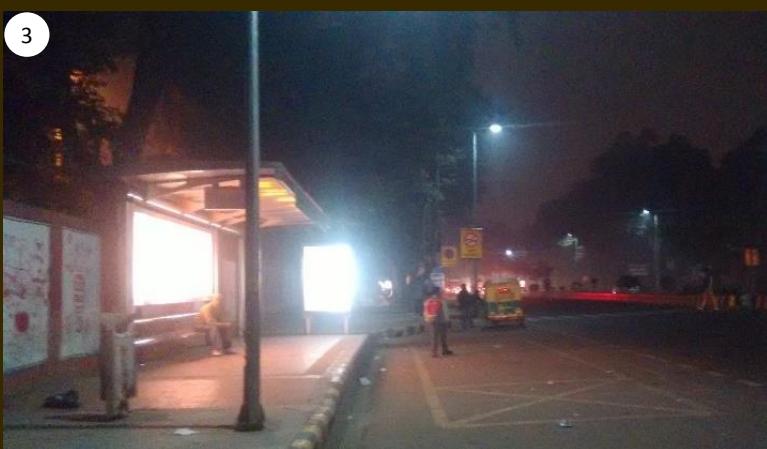
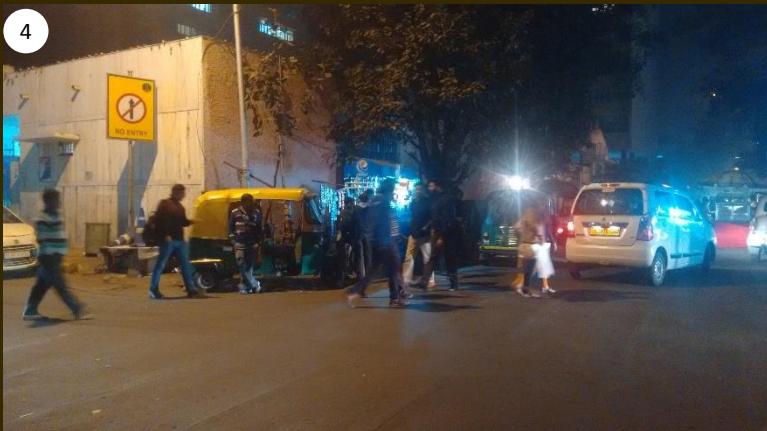
To improve last mile connectivity, para transit stands should be set up near the bus stops (Pic 3). Additionally, they should be set up in residential neighbourhoods and the market. Seen in Pic 4, an auto stand should be set up near Khan Market. The stand should have parking space for auto/taxi and designated space for vendors, clear of the walkpath.
