My City Initiative Delhi

a project by World Vision India

Safetipin, in collaboration with World Vision India, conducted safety audits in Lalbagh and Madanpur Khadar. The audits were conducted by the volunteers from the local community group supported by World Vision.

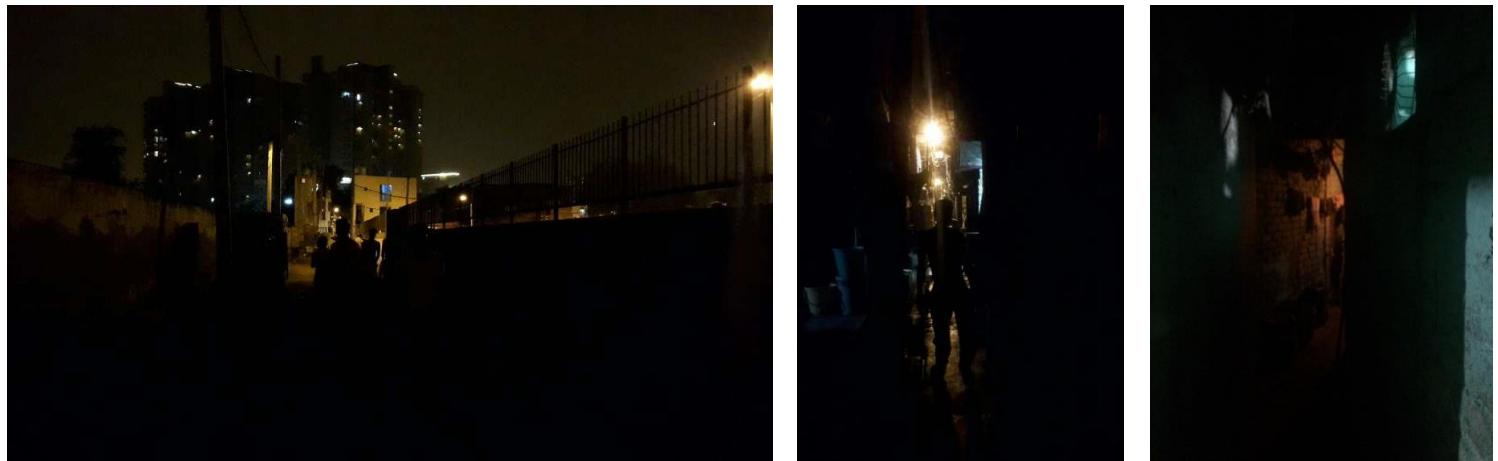
Lighting parameter has been rated 1.3/3 i.e. Average. The main Karnal Road is adequately lit. The Lalbagh market road is well lit due to the illumination from shops and hawkers. The presence of vendors also helps in otherwise poorly lit areas. Yet many areas were found to be extremely dark making one feel unsafe. Streetlights need to be installed along these areas such as the parking space along M2K Victoria Gardens. In the inner lanes also streetlights need to be installed. Along some lanes the streetlights already exist, however they were found to be un-operational. These need to be regularly maintained to ensure the area is well lit at all times.

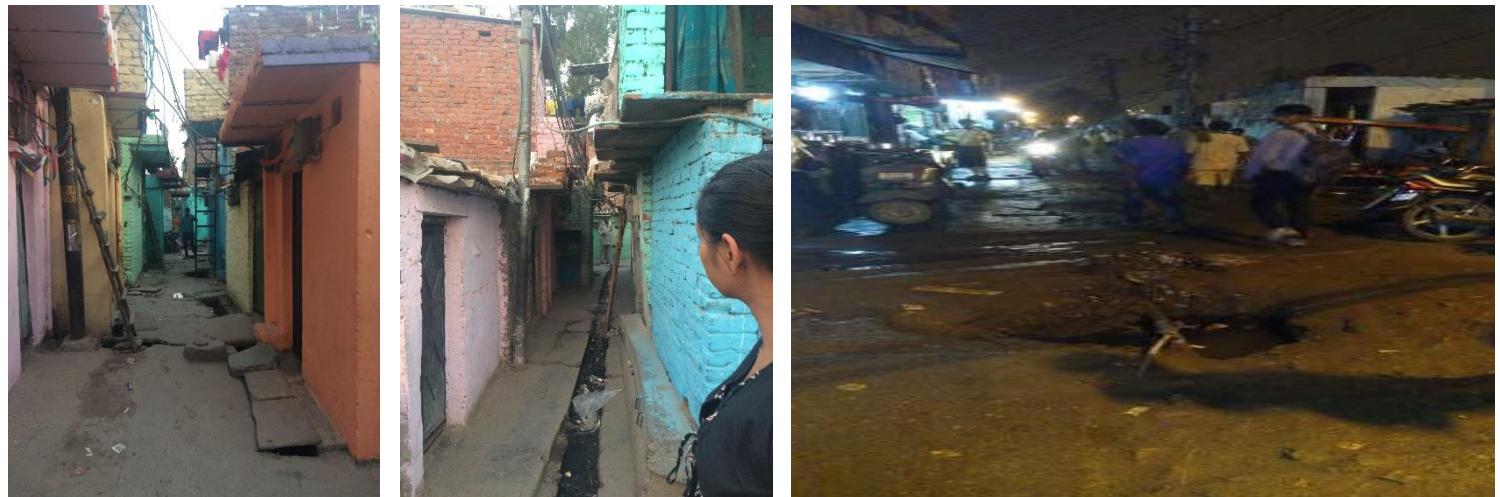
Walkpath parameter has been rated 0.2/3 i.e. Poor. Along the main Karnal Road there is a footpath though it is in poor condition along some parts. This needs to be repaired to provide a properly paved surface for people to walk on. Inside the neighbourhood, the main roads are wide but not enough to provide a separate pavement. However, currently due to increased vehicular movement and parking, there is no space for people to walk safely. At many places potholes and open drains were observed. Open drains are also common in the inner narrow lanes. These need to be covered and the drain cover should be flushed with the road surface. Vehicular movement should also be studied and re-worked.

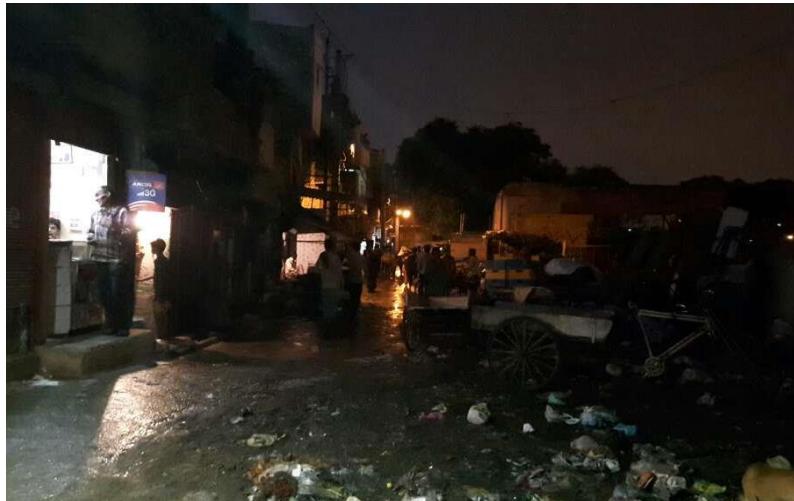
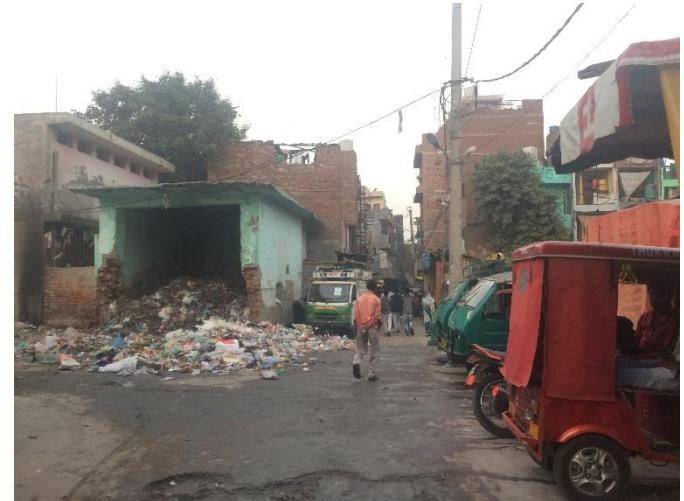
Public Transport parameter has been rated 1.4/3 i.e. Average. Autos and e-rickshaws are easily available along the main road and Block-C. But as one moves inside the neighbourhood away from the main road the ease of availing these facilities reduces as there is no dedicated stand or parking area for them. There are certain chowks inside where tempos etc are seen parked. A para-transit stand can be incorporated in such areas. Also as seen in the pics below, a lot of land is wasted on account of uncleared garbage. This space can be efficiently used for other activities.

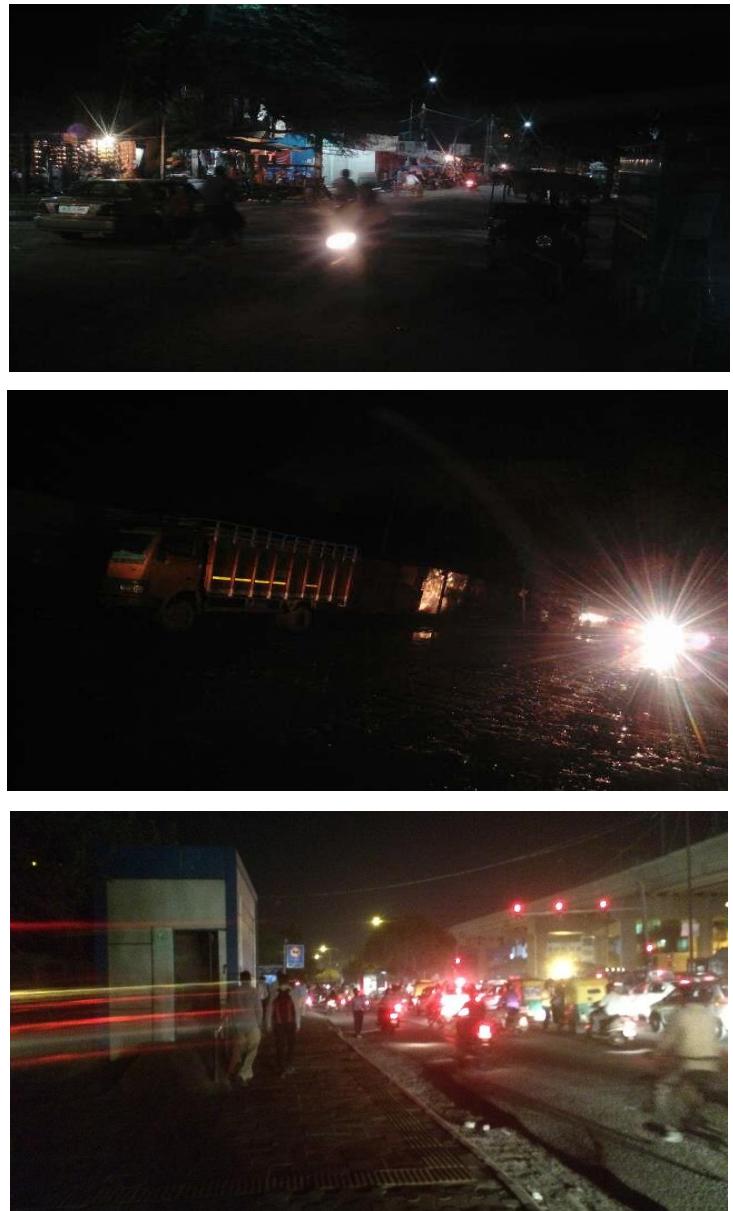
Lighting parameter has been rated 1.5/3 i.e. Average. Along the Mathura Road streetlights have been located along the central median. As a result the footpath leading to the metro station is poorly lit. Even the area outside the Public Convenience was poorly lit.

Along the Sarita Vihar residential area, certain stretch is lit but some part is poorly lit. Some streetlights were found to be un-operational. Also the light fixture is directed towards the vehicular carriageway while the footpath is not adequately lit.

Along the village the road is poorly lit as the streetlights are very far apart creating dark spots in between.

The road along the low lying area does not have streetlights and becomes very unsafe. In the market areas there is some illumination from both the streetlights and the vendors. But once the market closes the area becomes dimly lit.

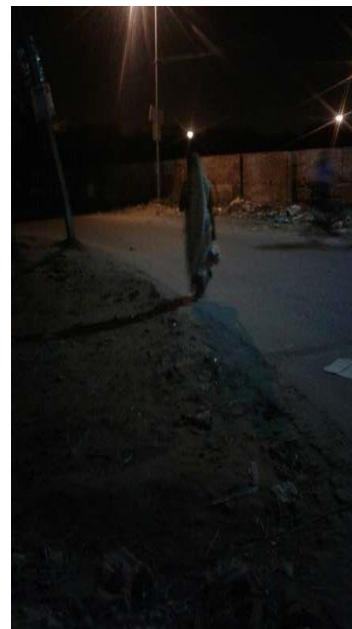
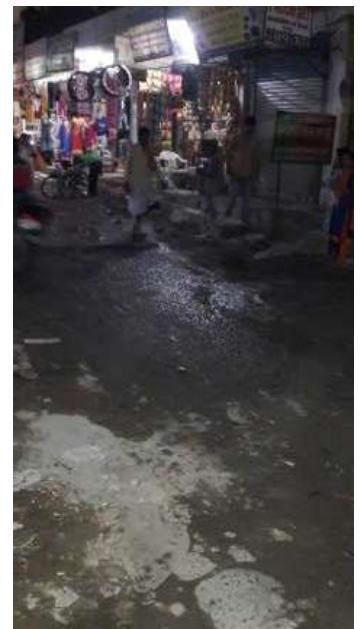
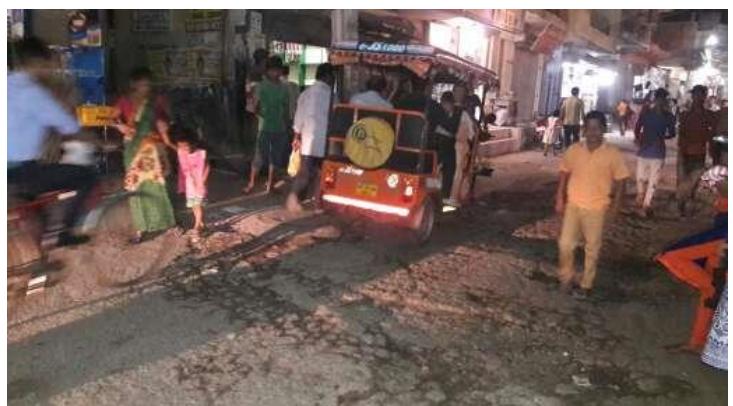
Walkpath parameter has been rated 1/3 i.e. Below Average. A good walkable footpath exists only at certain points along the Mathura Road and along the Sarita Vihar area. If the footpath exists then it is either broken or is obstructed by trees or vehicles parked on it. The footpath should be repaired. At points where it is obstructed by a tree, it should be widened. Patrolling and checks should be carried out to prevent vehicles being parked on the pavement.

Along the areas where the road is narrow and a separate pavement cannot be constructed, the road should be well maintained. Dedicated space should be created for hawkers. Houses and shops should not be allowed to extend onto the road as this further reduces the effective width of the road. Along certain parts space has been left for constructing the footpath. This space should be properly paved.
