M.G. ROAD, GURGAON

A SAFETY ANALYSIS

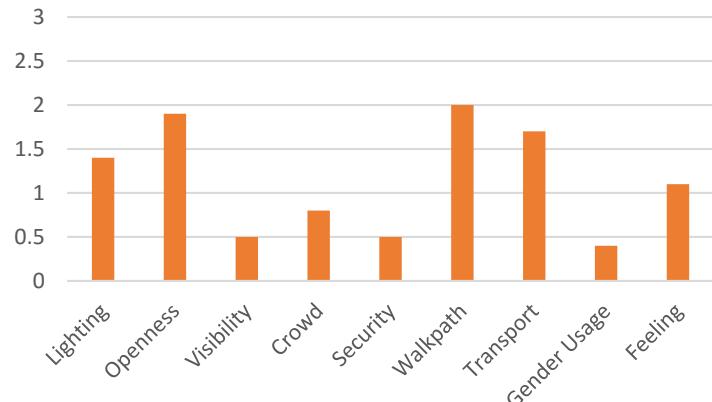
Average Audit Parameters (on a scale of 3)

The audits are based on nine parameters – Lighting, Openness, Visibility, Crowd, Security, Walkpath, Public Transport, Gender Diversity and Feeling. Of these, Visibility, Crowd and Security were rated poorly with Gender mix being rated very poorly. Almost no women are visible in this area in the evening hours. Most of the audit pins have been rated poorly for Gender Diversity. Some women were seen along the Malls and outside Office Buildings. Visibility and Security too have been rated very poorly in most locations.

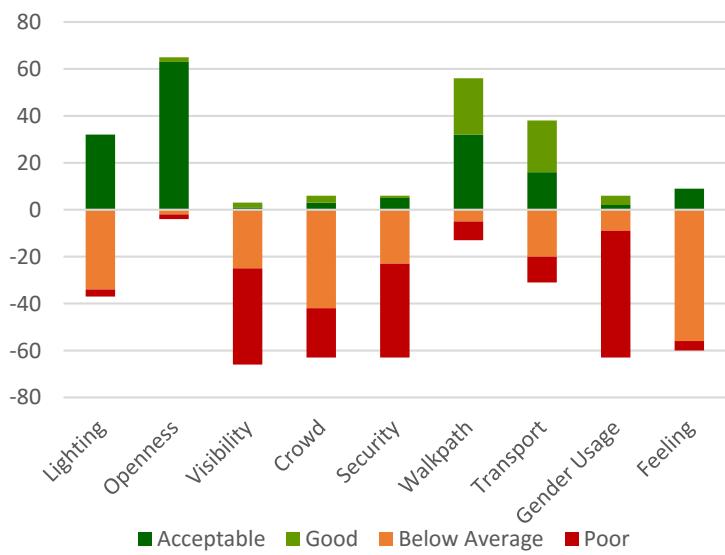
Pin Distribution for each Parameter

- **95% of the road has poor visibility.**
- **90% of the road has less crowd.**
- **91% has almost no women on the road.**
- **53% of the stretch is poorly lit.**

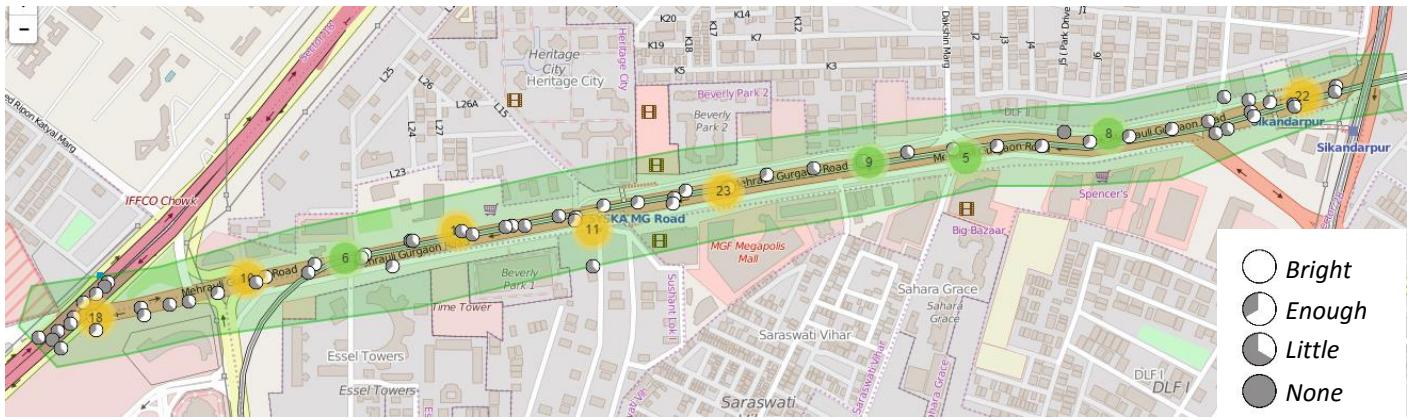
Lighting Rating

Lighting too has been rated below average. While certain locations have been rated as having acceptable levels of illumination, almost half the stretch has been rated being poorly lit.

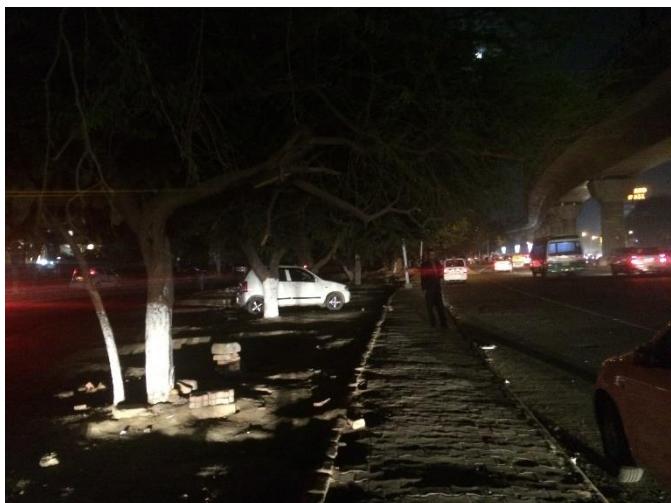
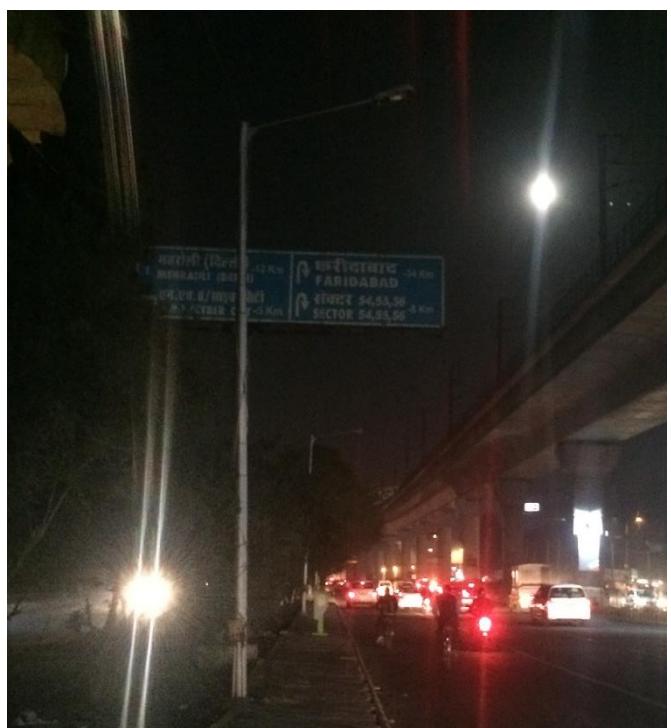
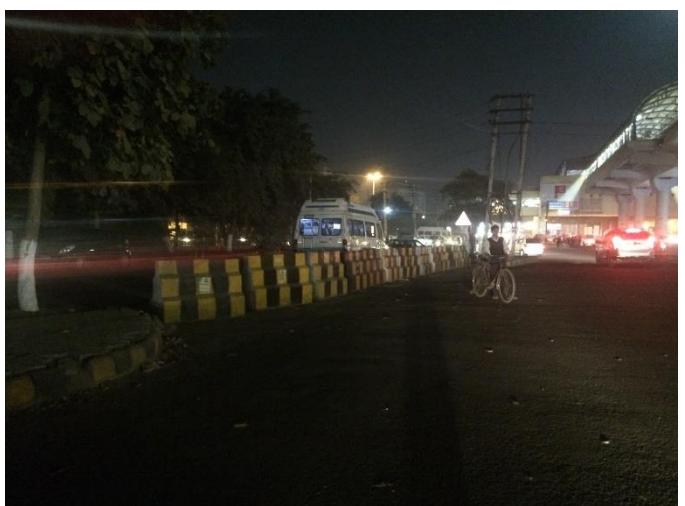
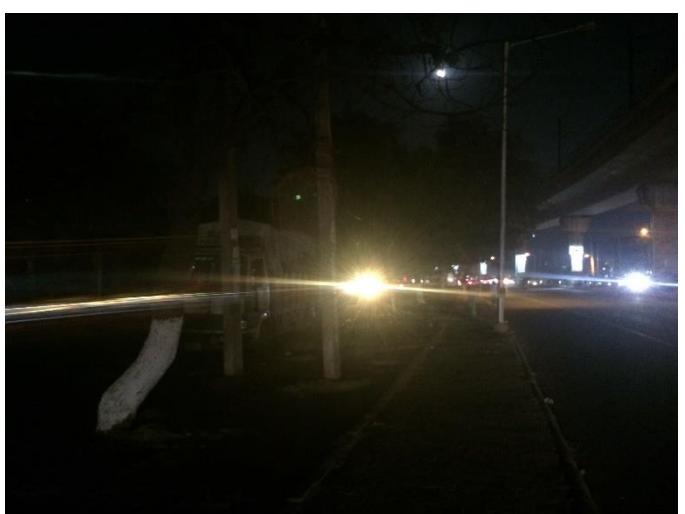
The Lighting along M.G. Road has been rated below average. At many points the light pole was found to be un-operational. In certain parts there is no provision for light poles and they need to be provided. These areas have some ambient light from the buildings or the hawkers present along the footpath. The service lanes are better lit because of light from the buildings but public street lights need to be provided along the entire road along the walkpath.

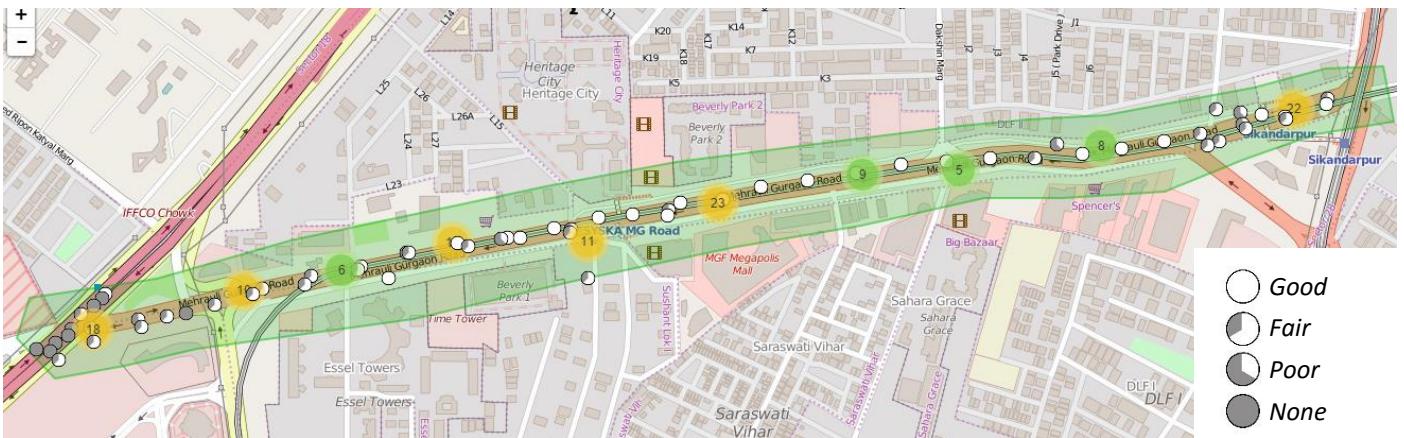
Walkpath Rating

The footpaths along M.G. Road are currently in a bad condition owing to various factors. Firstly, they are broken at a few locations. The paving is about to come off. At many locations, the footpaths need to be widened to prevent obstruction from trees. Also, at points where the dhalao/drain is located the gap needs to be bridged to ensure continuous pedestrian movement. The dust bins have been located in the centre of the walkpath making it very difficult. These need to be shifted to the edge of the footpath. The green strip along the footpath needs to be developed and be well lit. Currently, trucks are parked along these areas and the drivers use this for urination. Street Furniture and Public Convenience needs to be incorporated in this stretch.

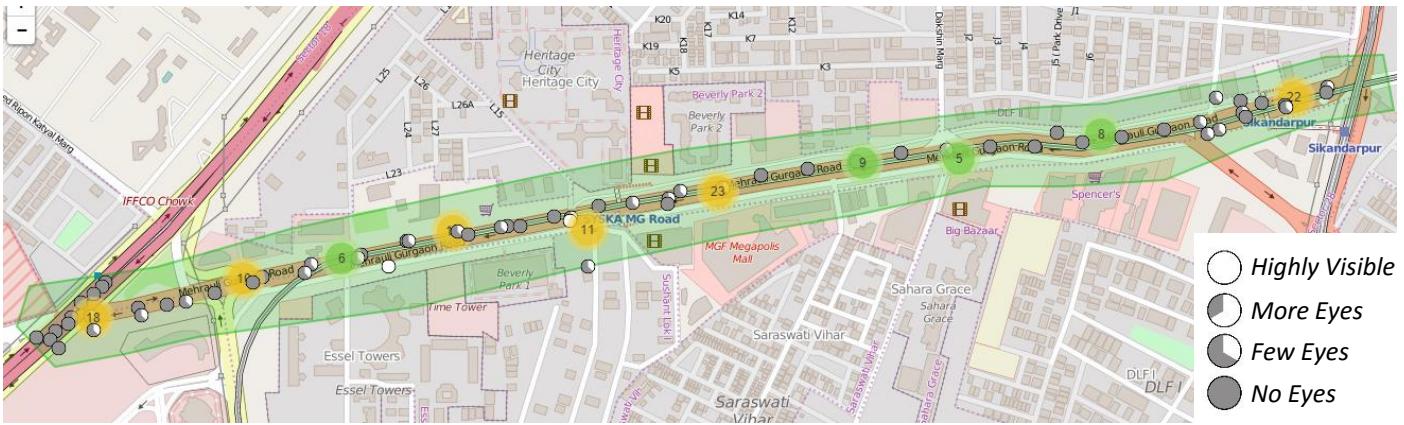
Visibility Rating

MG Road has a service lane on both sides due to which the built façade is pushed back reducing the visibility. The residential developments being the apartment type, they offer very low visibility to a woman on the road. However, this stretch sees some vendors it. The area along the malls has tea-water vendors. Along the residential areas also one spots many hawkers on the walkpath. Proper Zones for Hawkers need to be created such that the pedestrian movement isn't affected. These vendors are an important part of the road activity as they add the much needed "eyes on the street" enhancing the feeling of safety. Making provision for them is important. These zones should have public facilities and be well lit. Para-transit stands can also be incorporated along these zones.

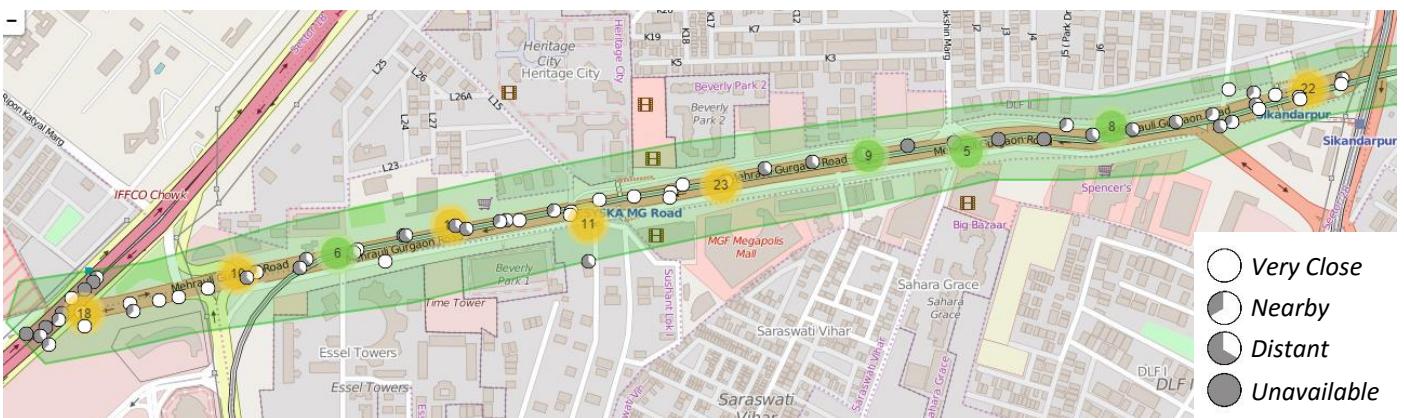
Rating of Public Transport

This stretch has two metro stations along it - M.G. Road metro station and the Sikanderpur metro station. Along each autos and cycle rickshaws are easily available. However, a certain stretch between the two still needs to be serviced. Building a para-transit stop for auto/taxi/cycle rickshaws will make commuting easier. This can be incorporated along the vacant strip of land along the walkpath. The stop should have Public Toilets among other facilities for the drivers and have to be well lit.
