NAIROBI

A Safety Analysis Report

EASTLEIGH

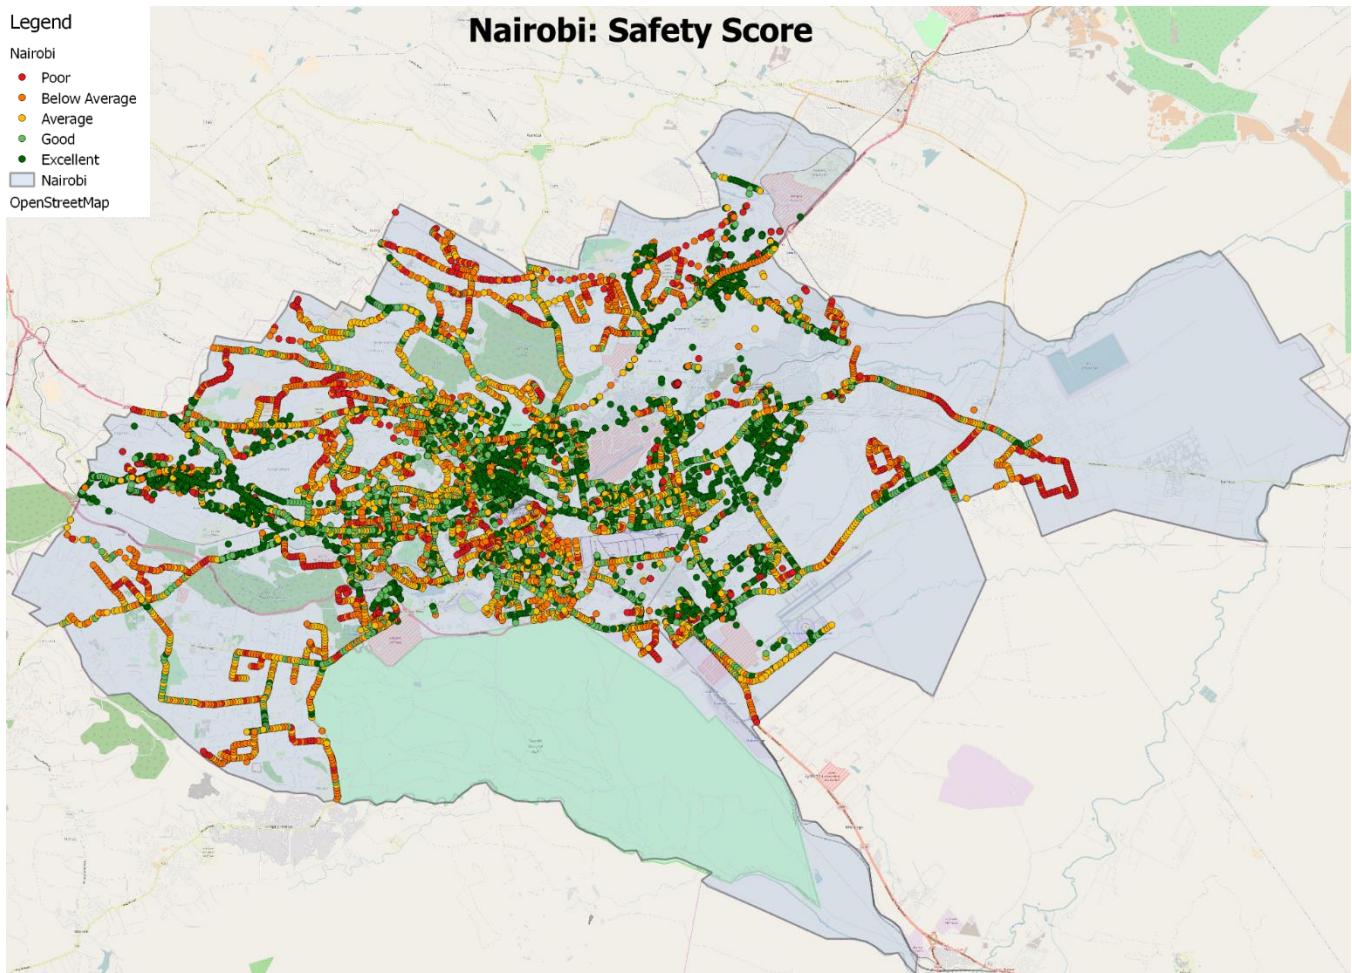
Map indicating Safety score of Nairobi

Indicated in the pie chart is the percentage distribution of pins in each range. The Safety Score has also been indicated in the map below. Around 43% of the audit points were found to be safe whereas 22% of the points were rated poorly and needs improvement.

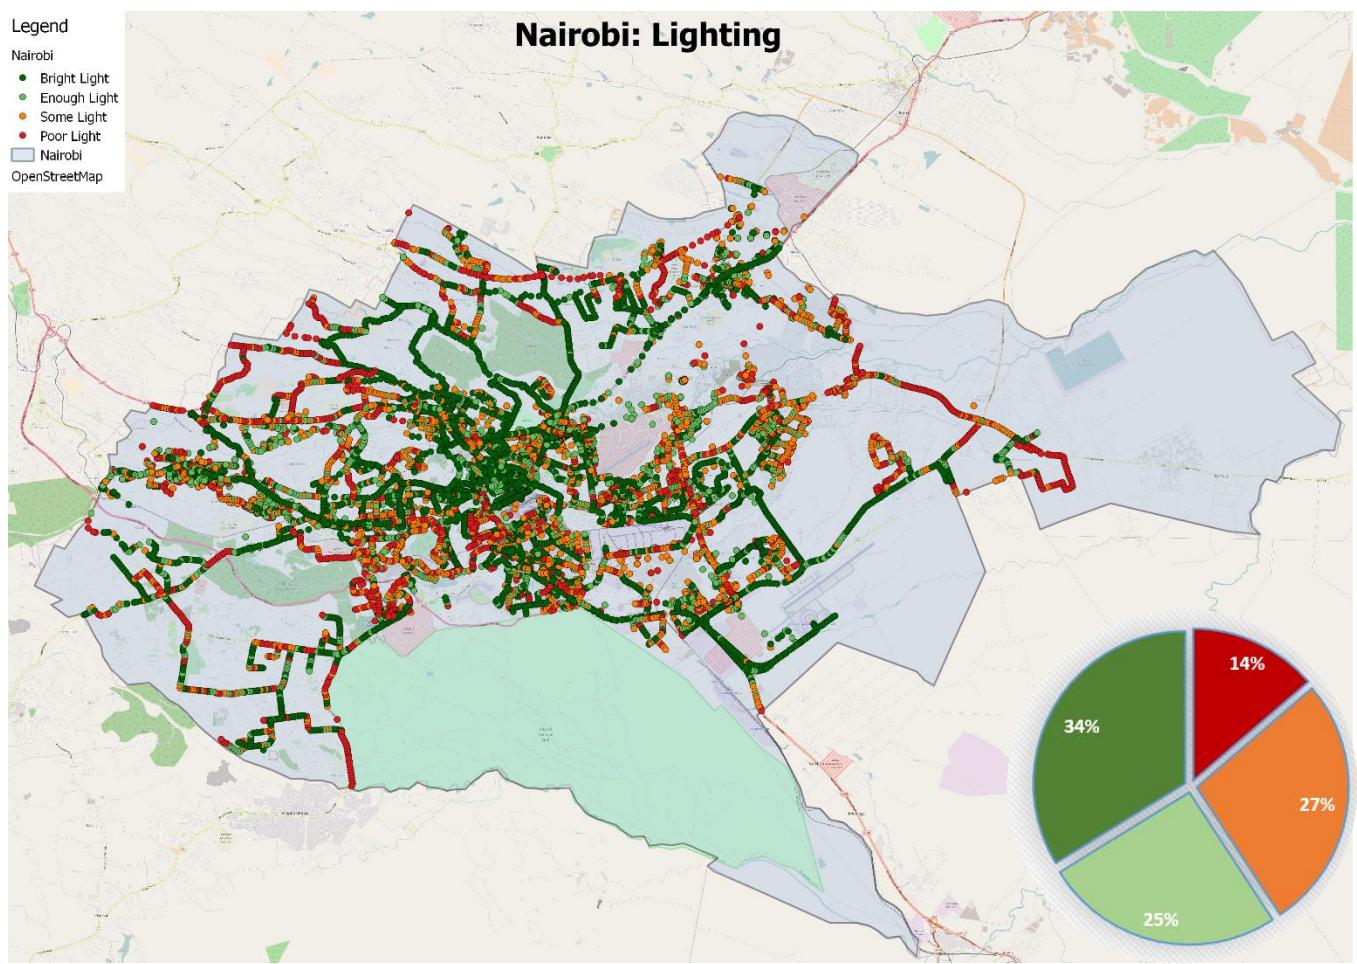
Nairobi: Lighting

The Parameter wise pin distribution graph indicates the number of points rated 0/1/2/3 i.e. the good points as positive and poor ratings as negative. The parameters of Security and Gender Usage have been rated poorly for most parts of the city followed by Visibility and Crowd. Lighting and Public Transport needs to be improved in some locations and the Walkpath conditions needs to be improved in few locations.

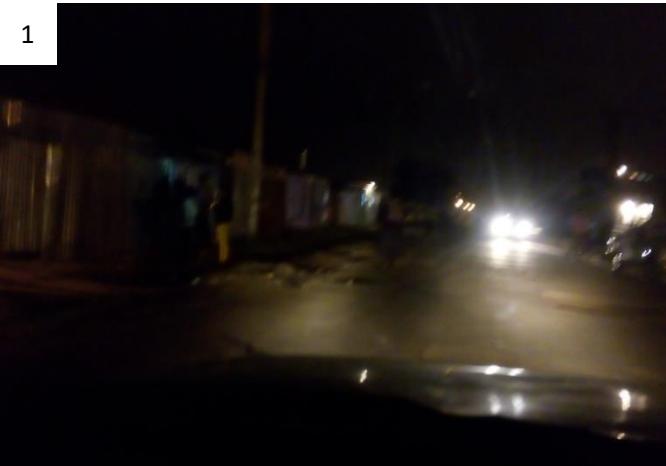
Lighting in Eastleigh has been rated 1.7/3 i.e. Average. At some points as seen in Pic 1, there were no streetlights. Some audit points were found to have poor lighting due to streetlights being inoperative or hidden behind trees' leaves. Street lights should be installed in areas where there aren't any along with regular maintenance checks to ensure their proper functioning.

The stretch with no streetlights

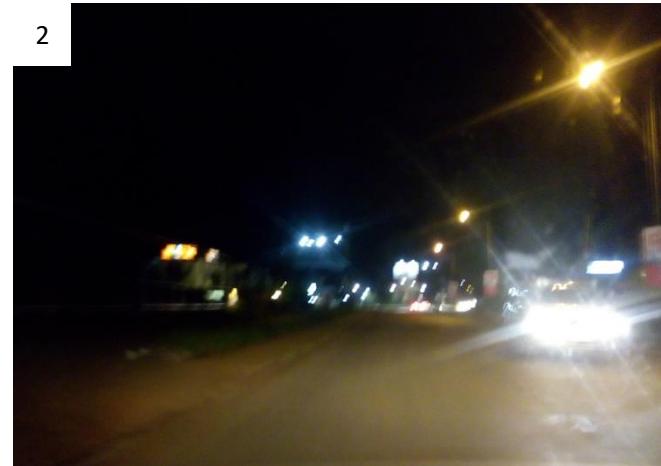
Lighting has maximum contribution to the feeling of safety for the pedestrians. As seen in Pic 2, the streetlights installed along one side of the road, results in well-lit roads but poorly lit footpath. Pedestrian scale streetlights should be installed on the footpath for the pedestrians. They should be installed along the edge of the footpath, clear of any obstruction.

Streetlights on one side

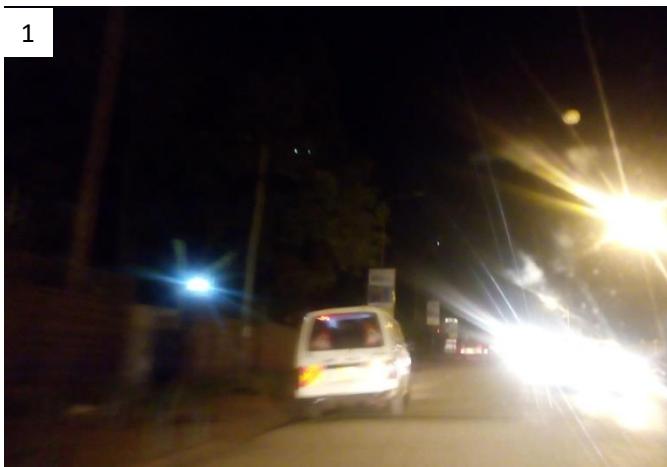
Walkpath in Eastleigh has been rated 1.8/3 i.e. Average. At some audit points as seen in Pic 1, unpaved pavement exists. The existing unpaved pavement should be paved and maintained to ensure smooth movement for the pedestrians.

Some stretches have unpaved pavement

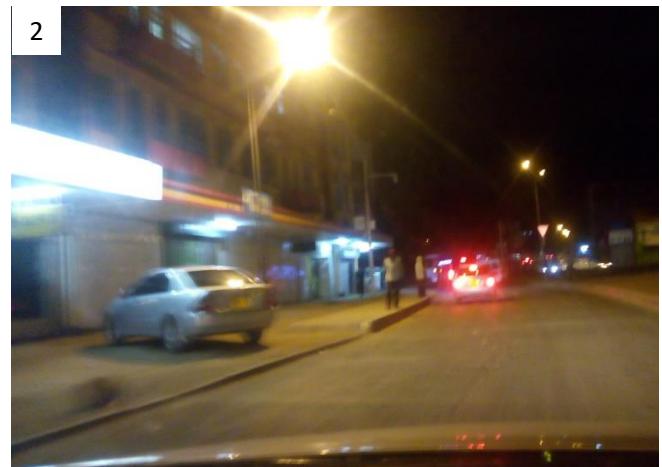
At points as seen in Pic 2, some audit points have car blocking on the walkpath thereby disrupting the pedestrian movement. To prevent vehicles from accessing the footpath, the footpath should be raised at a level from the road.

Car Blocking on footpath

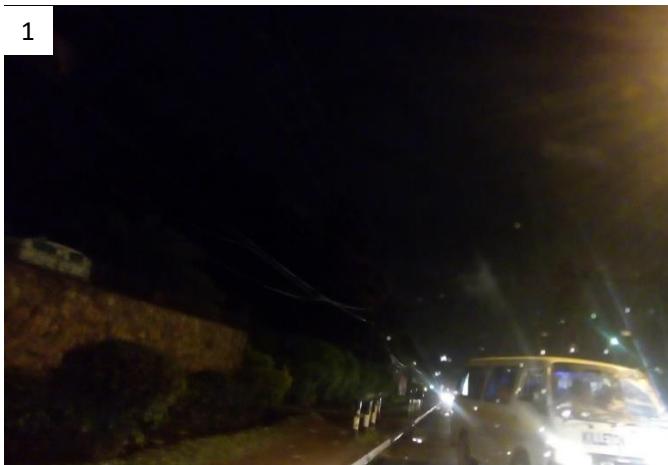
Visibility in Eastleigh has been rated 1.4/3 i.e. Average. As seen in Pic 1, most of the audit points have high boundary walls resulting in poor visibility. The “eyes on street” were found to be low with boundary walls creating a physical division between the pedestrians and the residents behind the walls.

Boundary wall leads to poor visibility

At some points, street side vendors and temporary shops were found acting as natural surveillance (Pic 2). To improve visibility, the height of solid part of the boundary wall should be reduced. Also at places where there are street vendors present, designated spaces should be made for them, clear of the pedestrians’ path.

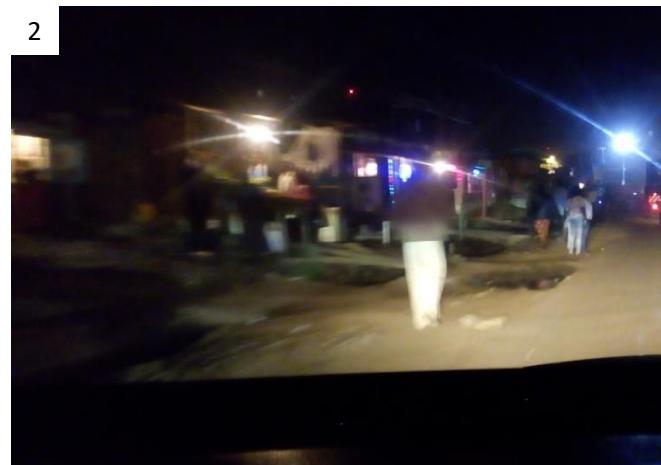
Temporary stalls and vendors offer some visibility
