SHAHJAHANABAD

SAFETY AUDIT REPORT

Safety Audits were conducted by INTACH and SafetiPin in Delhi's walled city of Shahjahanabad. The audits were done to assess the infrastructure and services gaps that exist in the area and to document these as objective data. This can then be used as an advocacy tool to facilitate upgradation of the area.

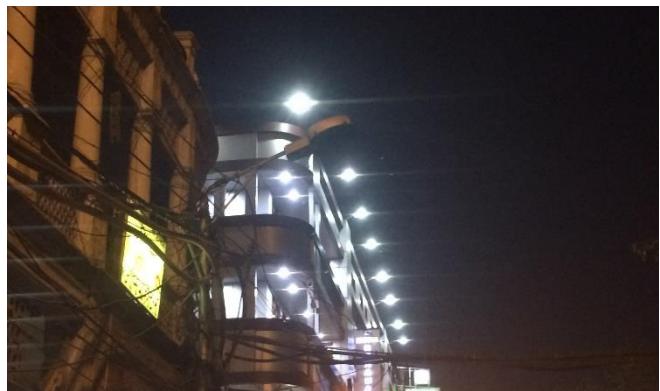
Many streetlights don't work and the area is well lit by light from the shops.

- **Overhead electrical wires need to be shifted underground.** Also, the infrastructure provision should not pose a threat to human safety.
- **Improve Street lighting.** There is provision for street lighting. However, it is insufficient. Many old light poles without the lamp can be spotted. A lot of the street lights do not work. The area is well lit by the light from the shops. After the shops close i.e. after 8pm, the area becomes dark. Dark spots have also been identified in certain areas where there are no shops.

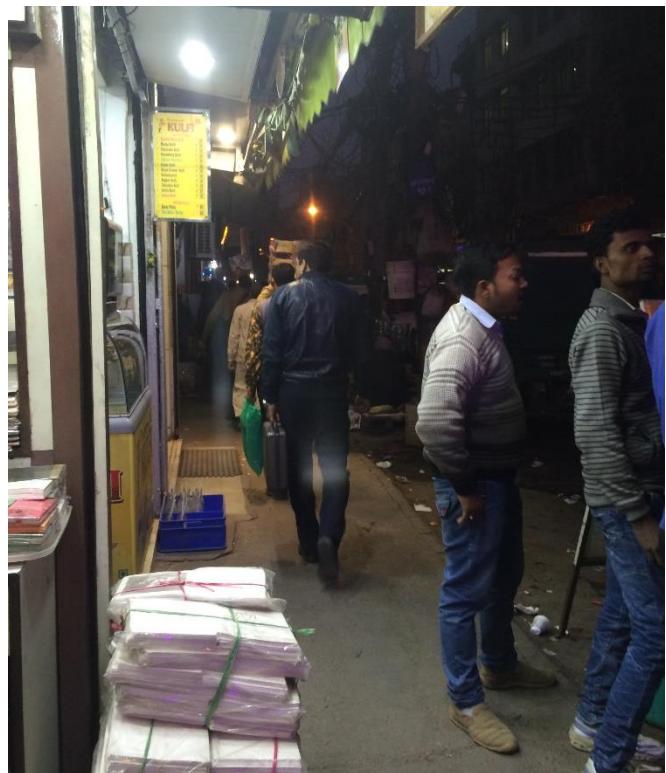
Movement & Storage of Goods along public right of way.

- **Regulation of movement of goods.** The shops have goods delivered throughout the day. Autos, cycle rickshaws and hand pulled carts are all parked along the road. This causes congestion hindering both pedestrian and vehicular movement.

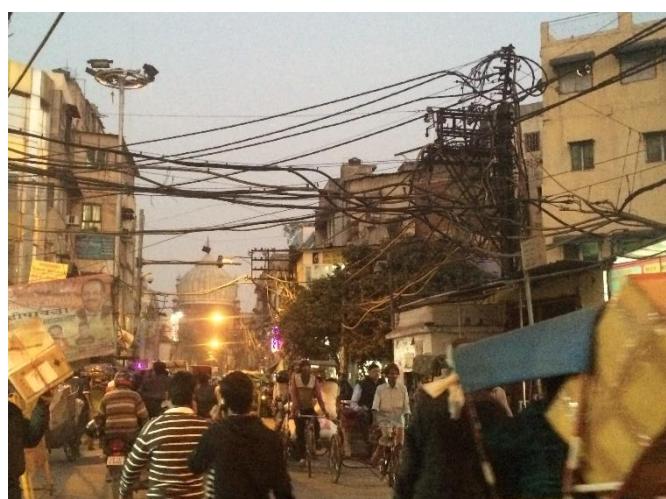
Safety Audits reveal that certain issues are common across all nine areas. The exposed electrical wires are a major threat to life and property. In many places they are very close to the windows of buildings and also hanging very low in the streets. Another major issue is the loading/unloading of goods taking place throughout the day. This adds to the congestion on the streets already choked with vehicles.

Electrical Wires along with being a safety hazard also add to the visual clutter, affecting the experience of the heritage city.

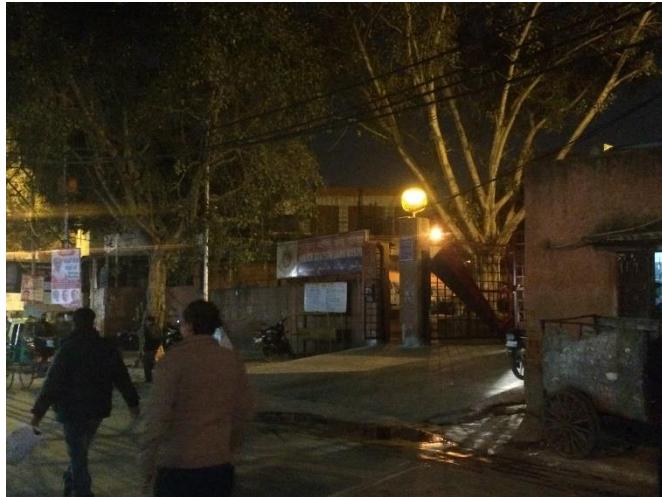
The public toilet is located with it's entrance facing the walk path which makes it extremely uncomfortable for women to use it.

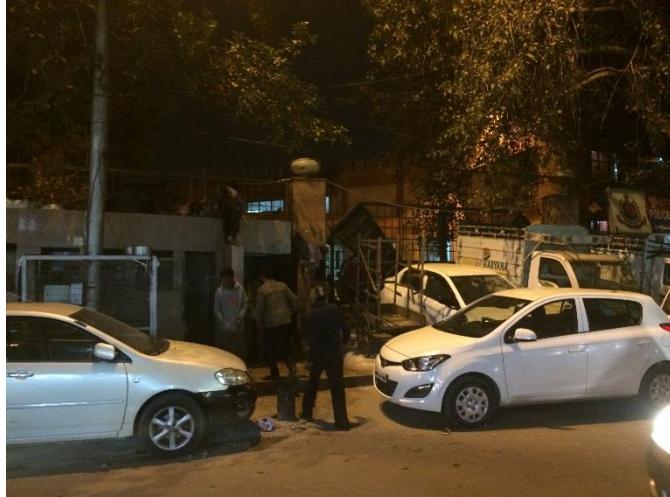
The walk path is also used as a dumping ground for disused items.

- **Maintenance of Walkpaths.** The walkpaths are broken in many parts. Some shop owners are maintaining the path in front of their shops. Also, the stalking of goods along the walk path needs to be prohibited. In certain areas, the footpath needs to be widened. There needs to be regular checks for monitoring and maintenance.

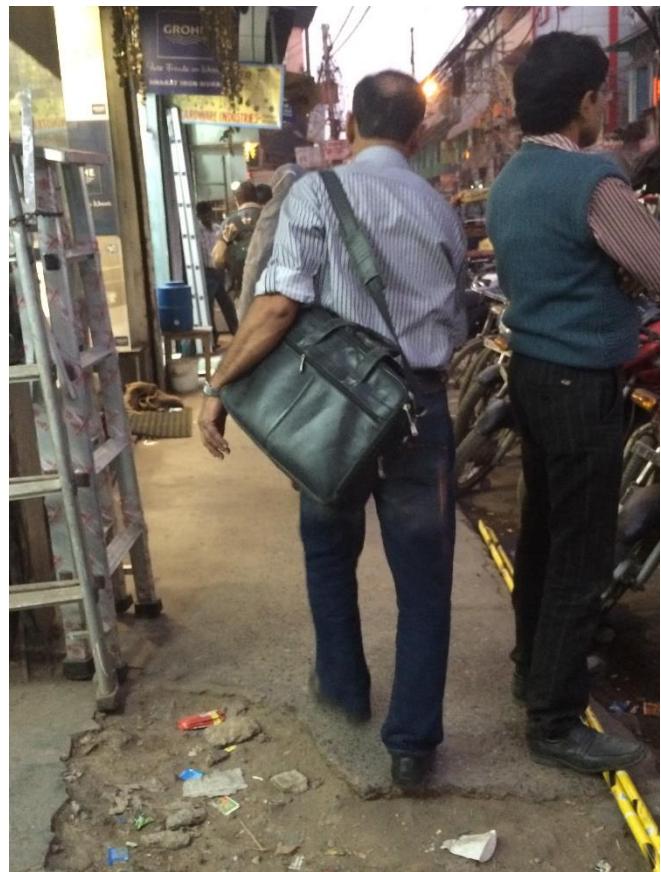
There exists a dedicated walk path in most areas. However, it is not being maintained making it difficult to walk on. These are also being used for displaying of goods by the shops, impinging on the walking space.

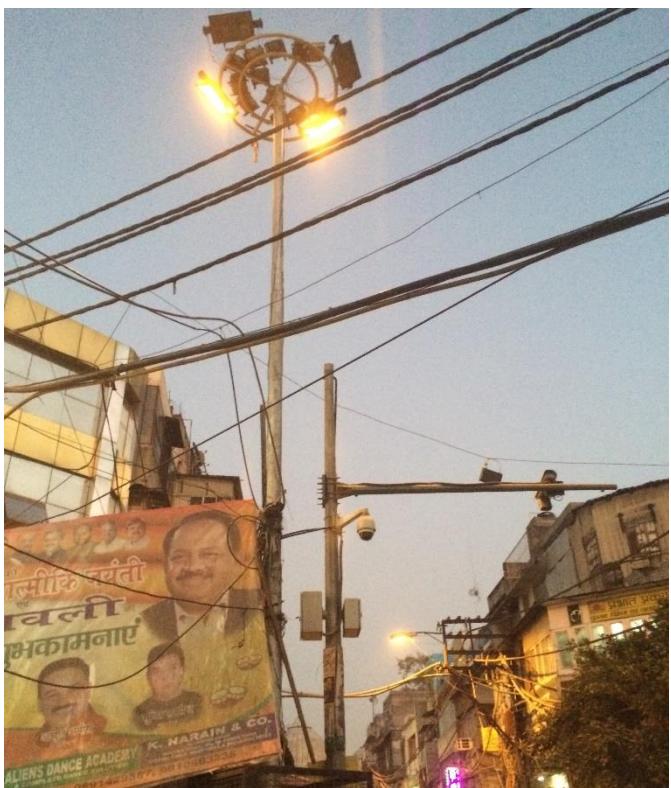
CCTV Cameras have been installed in many areas like chowks, junctions and outside metro stations. This adds to the feeling of security.

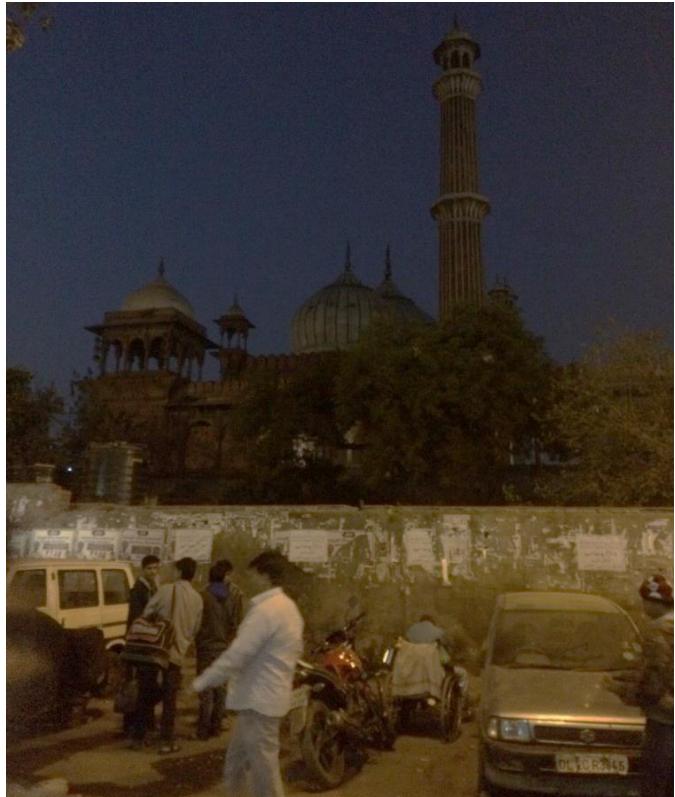
Dead spaces encourage homeless people to locate themselves and men to loiter. For women these areas are uncomfortable to pass by.

- **Activate dead zones.** The areas along blank boundary walls and where the back of a building defines the street edge, these need to be activated. The areas being used for dumping need to be cleared. Street Furniture can be provided which would allow for better use of the area. For example, the area along the secondary entrance to the Jama Masjid. Clearing the area and turning that into a cycle rickshaw stand could ease congestion on the main entry side. Provision can then also be made for hawkers to locate themselves there.

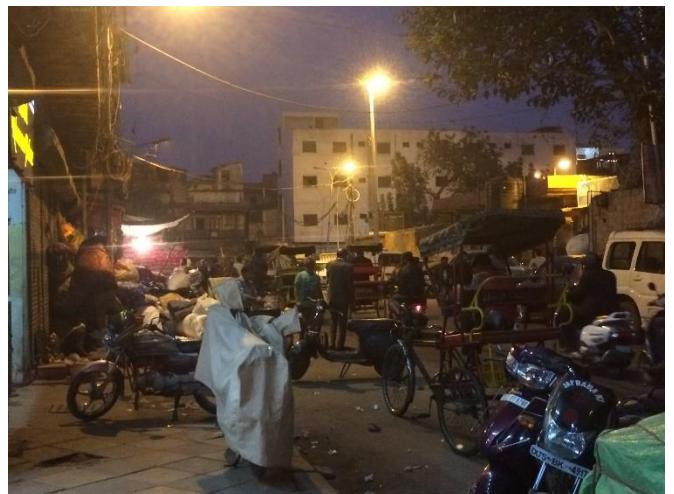
Goods and vehicles located on the walk path and along the street make it difficult for everyone to walk.

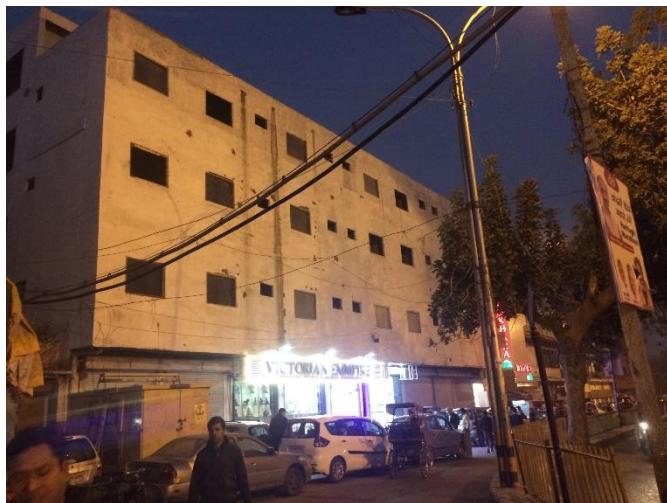
The new buildings being constructed have a different visual aesthetics. The number of windows looking onto the street is reducing.

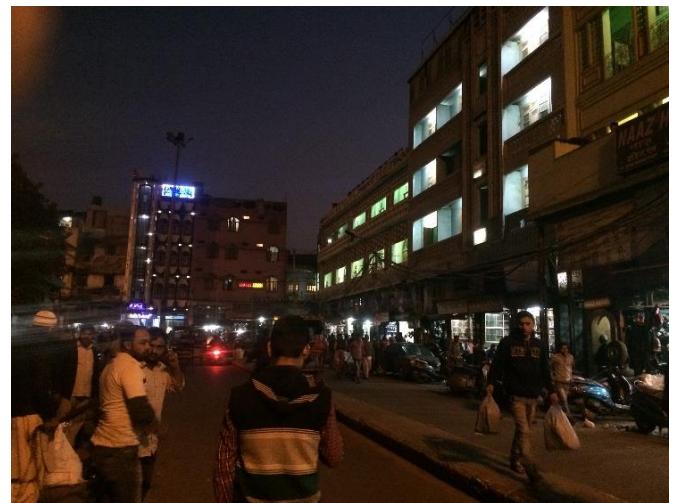
The old buildings in the area have more windows and balconies, they thus offer greater visual connectivity with the street making them feel safer.

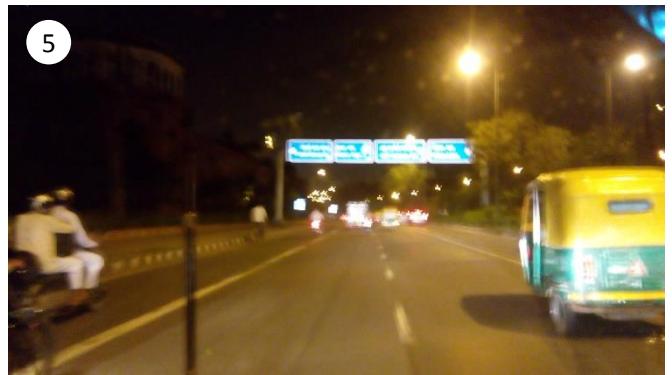
Being an arterial road, this stretch is wide open but there are no pedestrians using it.

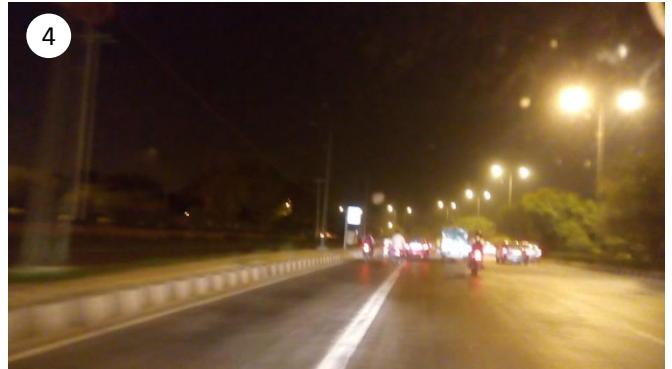
No pedestrians as no activity happening along this stretch to attract people.

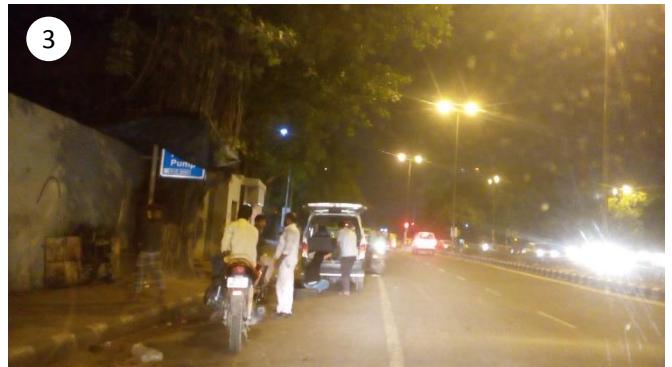
Walk path flanked by high boundary wall. Signage is partially covered. Also only men loitering on the road.

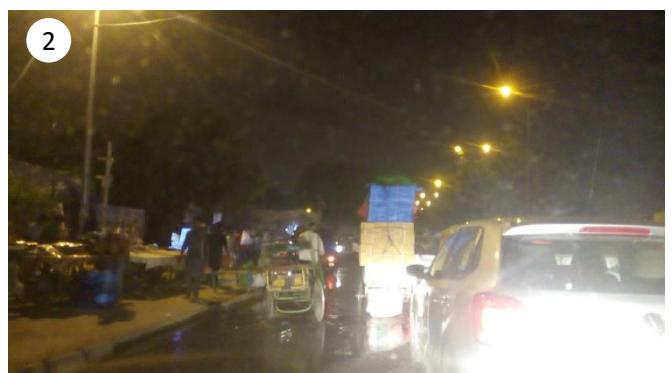
Walk path occupied by vendors

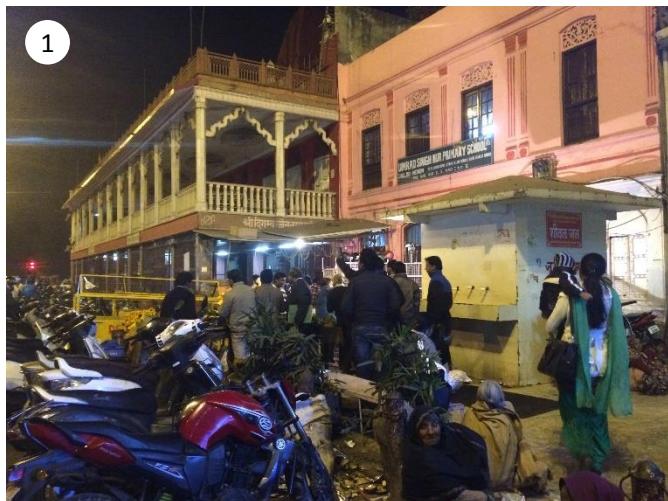
Public facilities have been provided but the walk path needs to be provided integrating these.

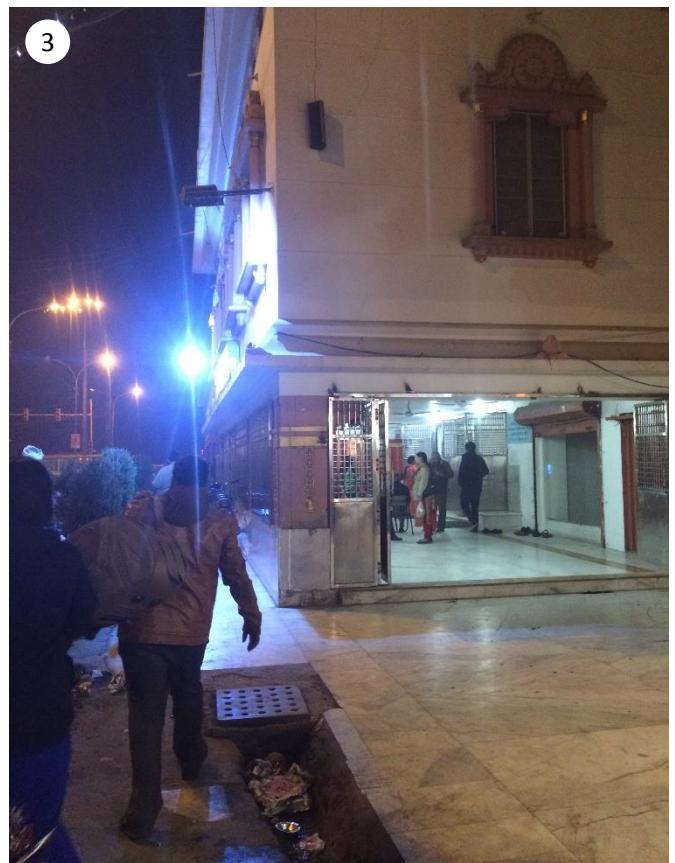
The religious buildings tend to extend into the public right of way. The need to take off ones shoes makes the area inaccessible to the passer by.

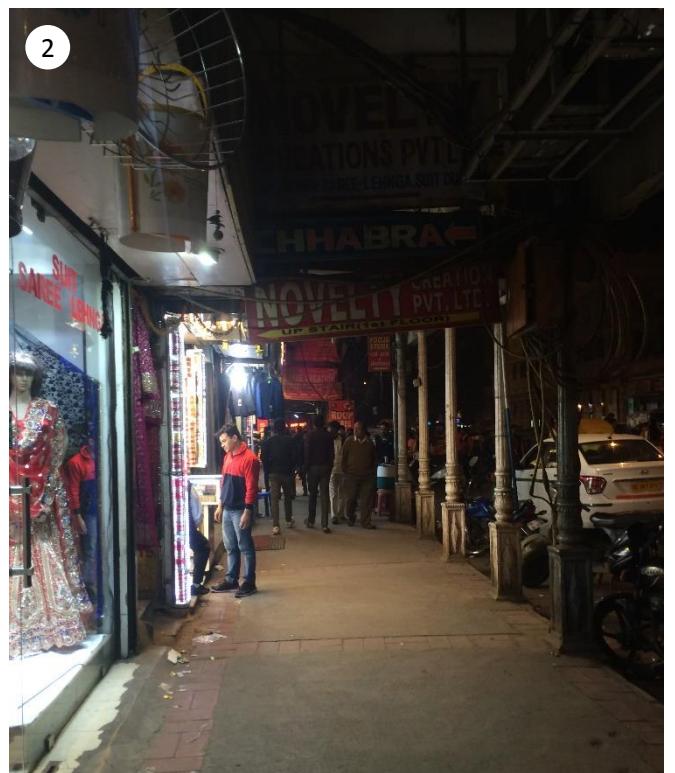
The stretch has a colonnaded walk path or an open path atleast on one side of the road. This is in fair condition in most parts. However, it is lit only by the light from the shops. Also, a lot of wires are seen hanging over it.

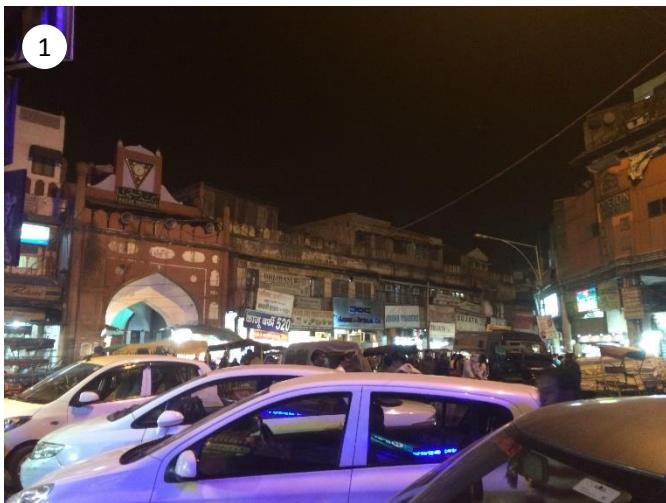
The entrance to the Masjid is from a chowk. This is very congested and the open area is used to park more private vehicles.

- **Creating Vehicular Parking Zones.** In the absence of defined parking zones, private vehicles are all parked on the road. Proper parking zones need to be created. These have to be located to ensure they are convenient to use. The existing parking areas, for example the one near Meena Bazaar needs to be upgraded.

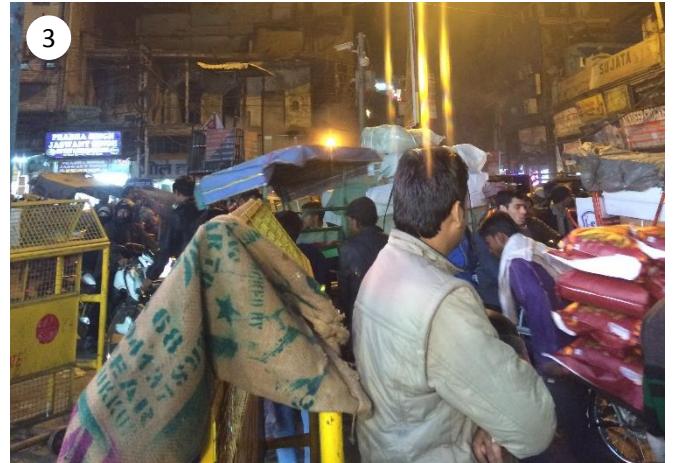
There is a police booth at the junction but at times there is no policeman present.

- **Improve Police Presence.** Ensuring that this is constant police patrolling in the entire area will make it safer.
- **Space for Hawkers.** In the absence of any designated space, the hawkers and vendors locate themselves on the street or on the footpath.

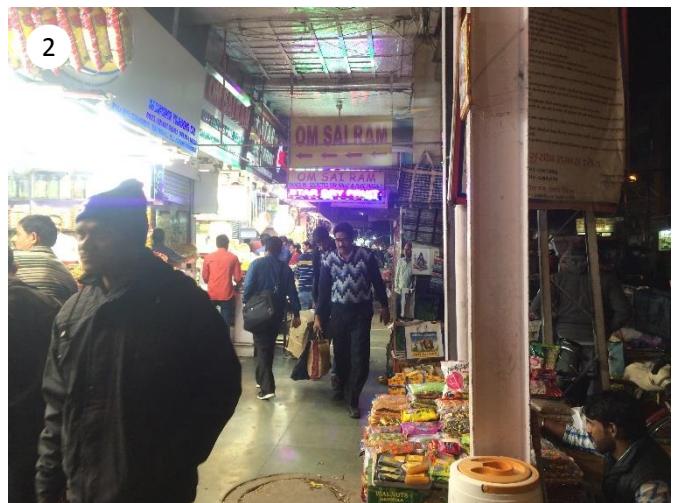
The stretch has a walk path which is in a fair condition in most parts. However, the hawkers occupy parts of it reducing the space for walking.

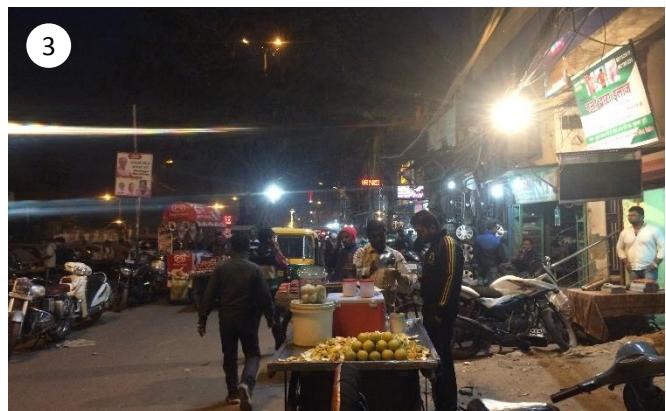
The area around the mosque is lined with shops on the ground floor. These spill out onto the road. Private vehicles too are parked on the road itself. These make the area extremely congested.

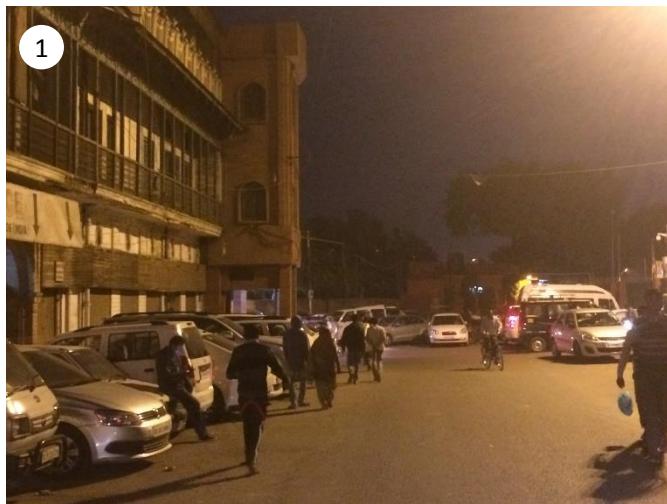
The buildings define the road edge followed by cars parked along it. In the absence of any walk path, people walk on the road itself.

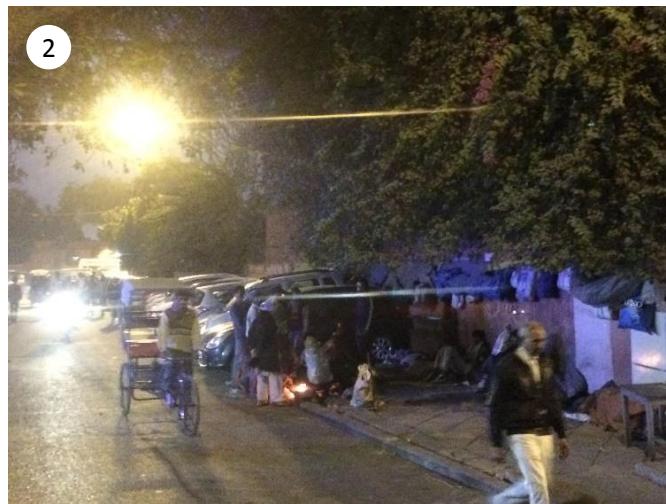
The high boundary walls provide a support for homeless people. While they do enhance the visibility, they make these parts uncomfortable to cross despite the walk path being a wide one.

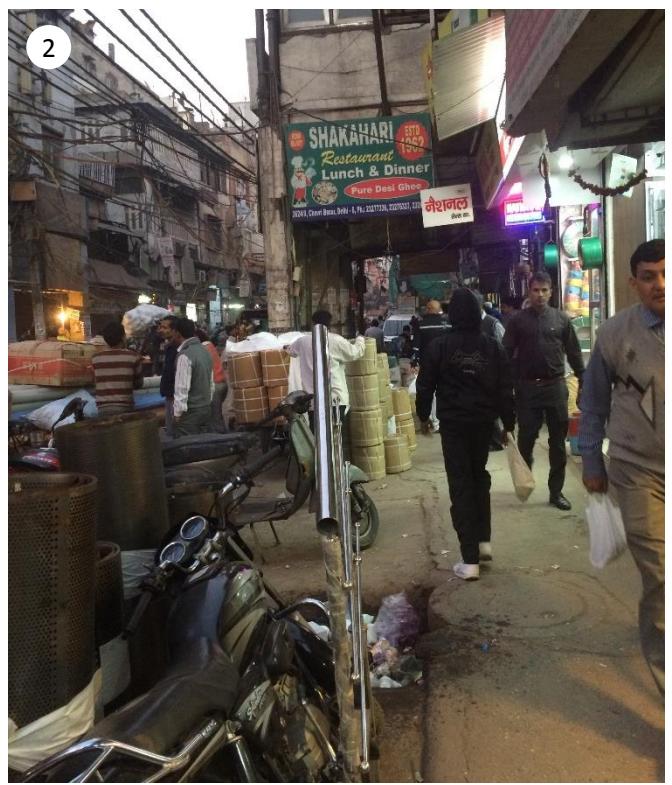
The goods are stored on the footpath and along the road causing hindrance to pedestrian movement.

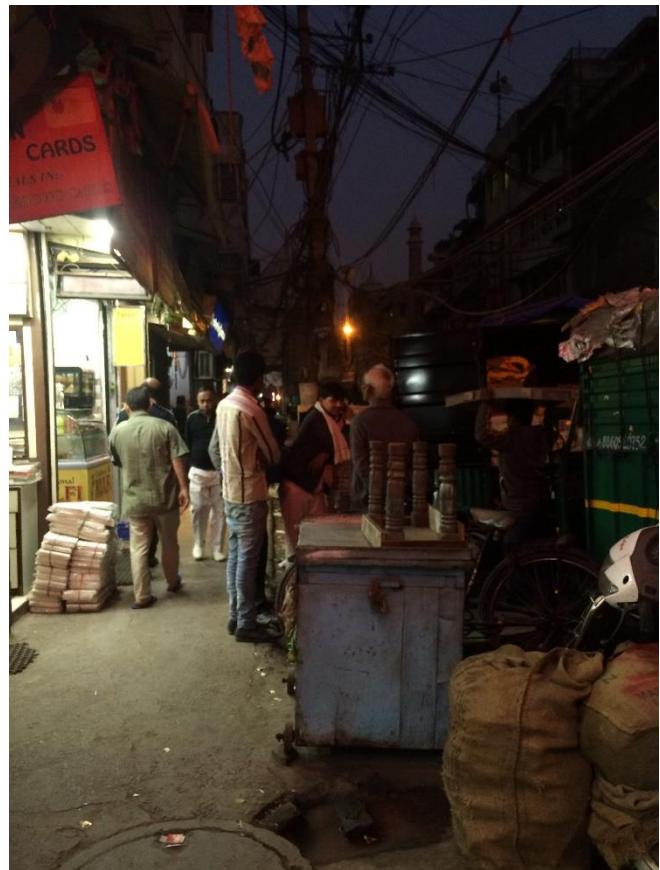
Congestion on the street

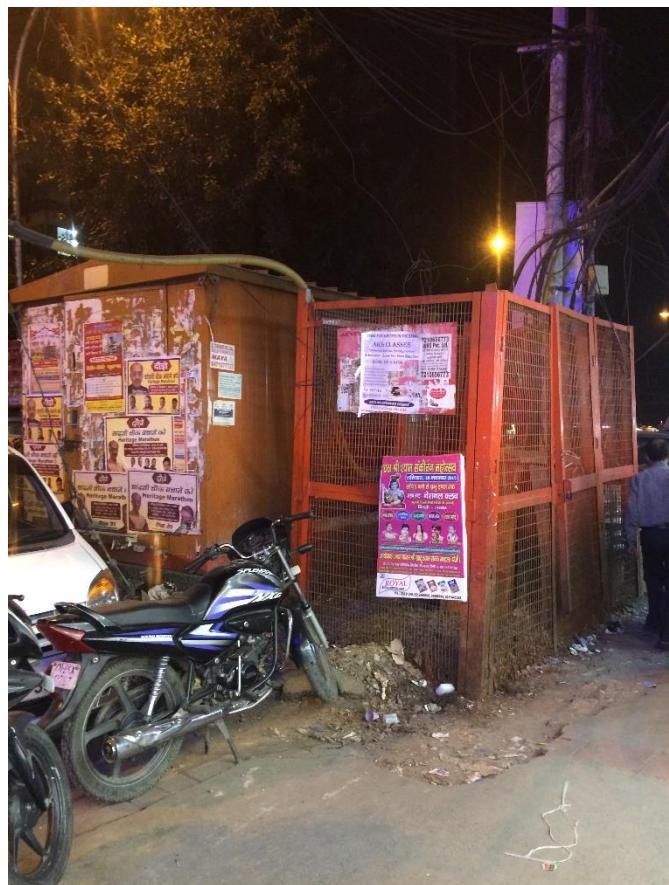
Transformers and electrical wire along the street.
