ENHANCING LAST MILE CONNECTIVITY

a safety analysis of the Khan Market Metro Station

This Report has been prepared as part of the Project being undertaken with NDMC to Enhance the Last Mile Connectivity along the metro stations within its jurisdiction. The safety audits were conducted by Smt. Bhagwati Bisht, architect from NDMC along with Safetipin team.

Khan Market

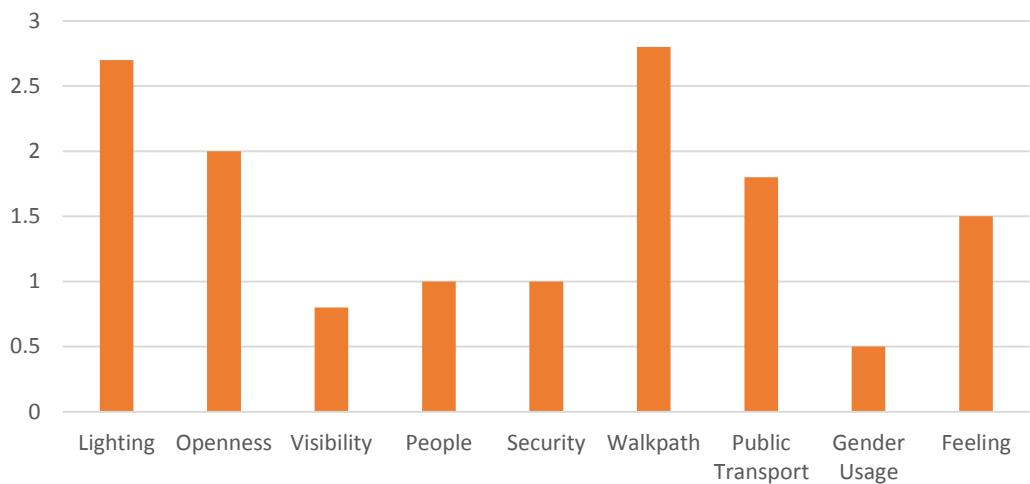
Average Audit Parameters (on a scale of 3)

Safety Audits indicate that the area around the metro station is safe. At a few spots near Delhi Golf club, the safety score was found to be lower than the rest of the audit area. The parameter of Security has been rated Below Average. As most of the buildings have high boundary walls, Visibility has been rated below average as well.

Public Transport in this area has been rated Average. The parameter of the People and Gender have been rated Below Average and Poor respectively. The parameter of Lighting and Walkpath has been rated Good. Overall, auditors have rated the Feeling in this area as Average.

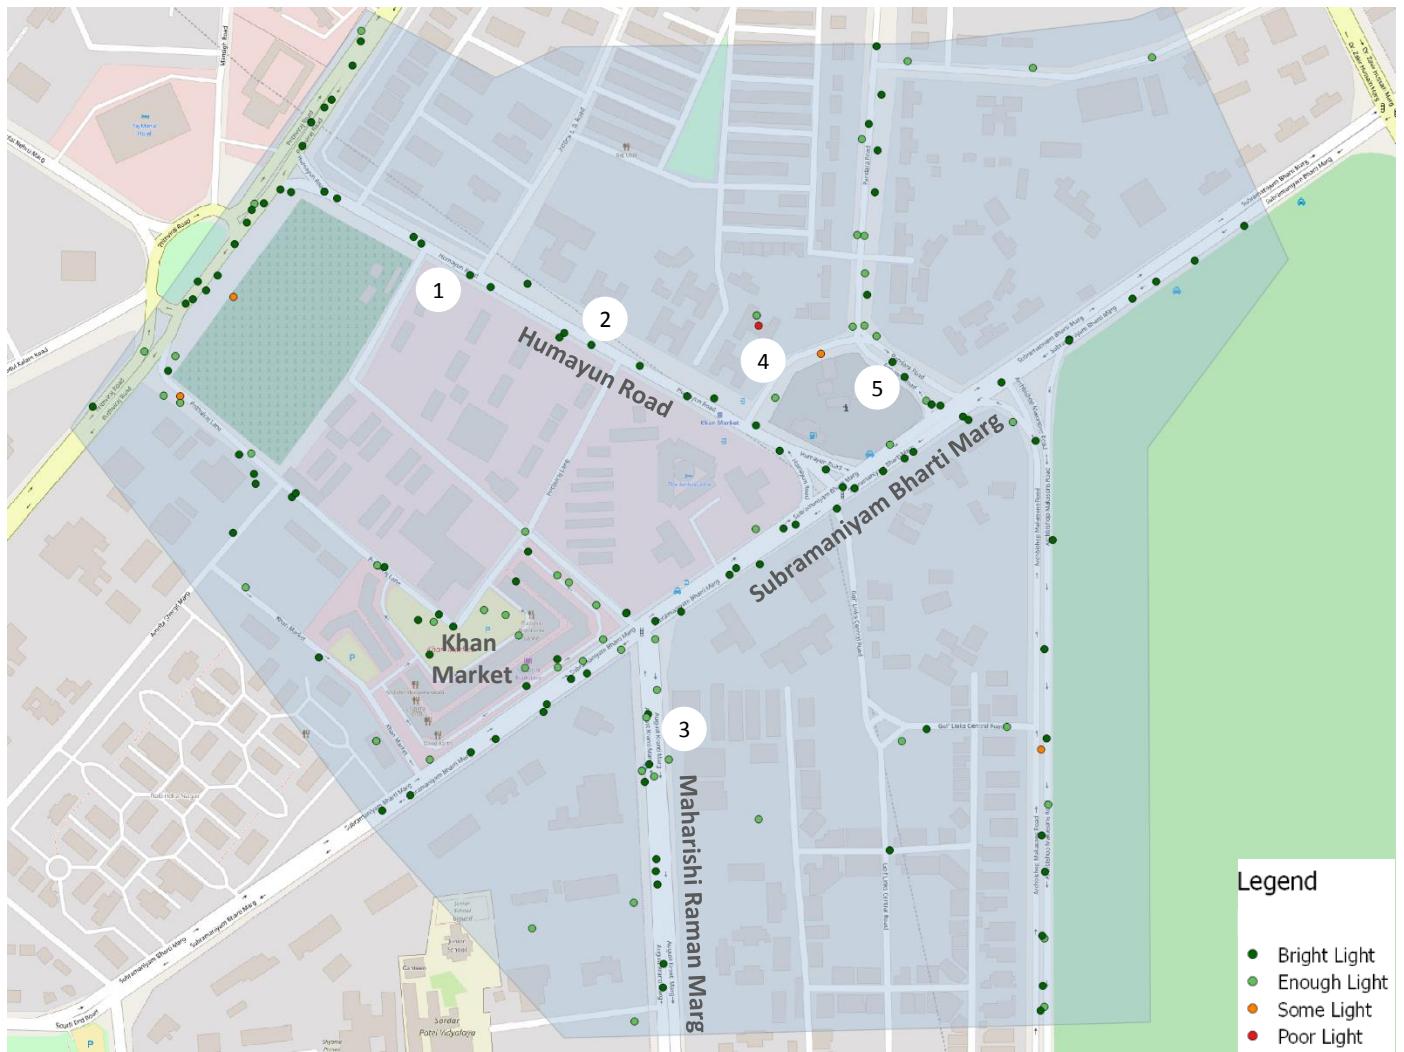
Lighting Rating

Lighting Parameter has been rated 2.7/3 i.e. Good. Streetlights are installed on both sides of the main road throughout the audit area. Streetlights are installed on the edge of the footpath facing the carriageway resulting in the brightly lit road but dim lit footpath. Additional streetlights need to be installed to provide pedestrian scale lighting on the footpath.

Also, at some points streetlights are hidden behind trees' foliage. They need to be pruned regularly. On Maharishi Raman Marg, the spread of installed LED streetlights is low. The Lux level has to be increased for the same so as to provide proper illumination on the road.

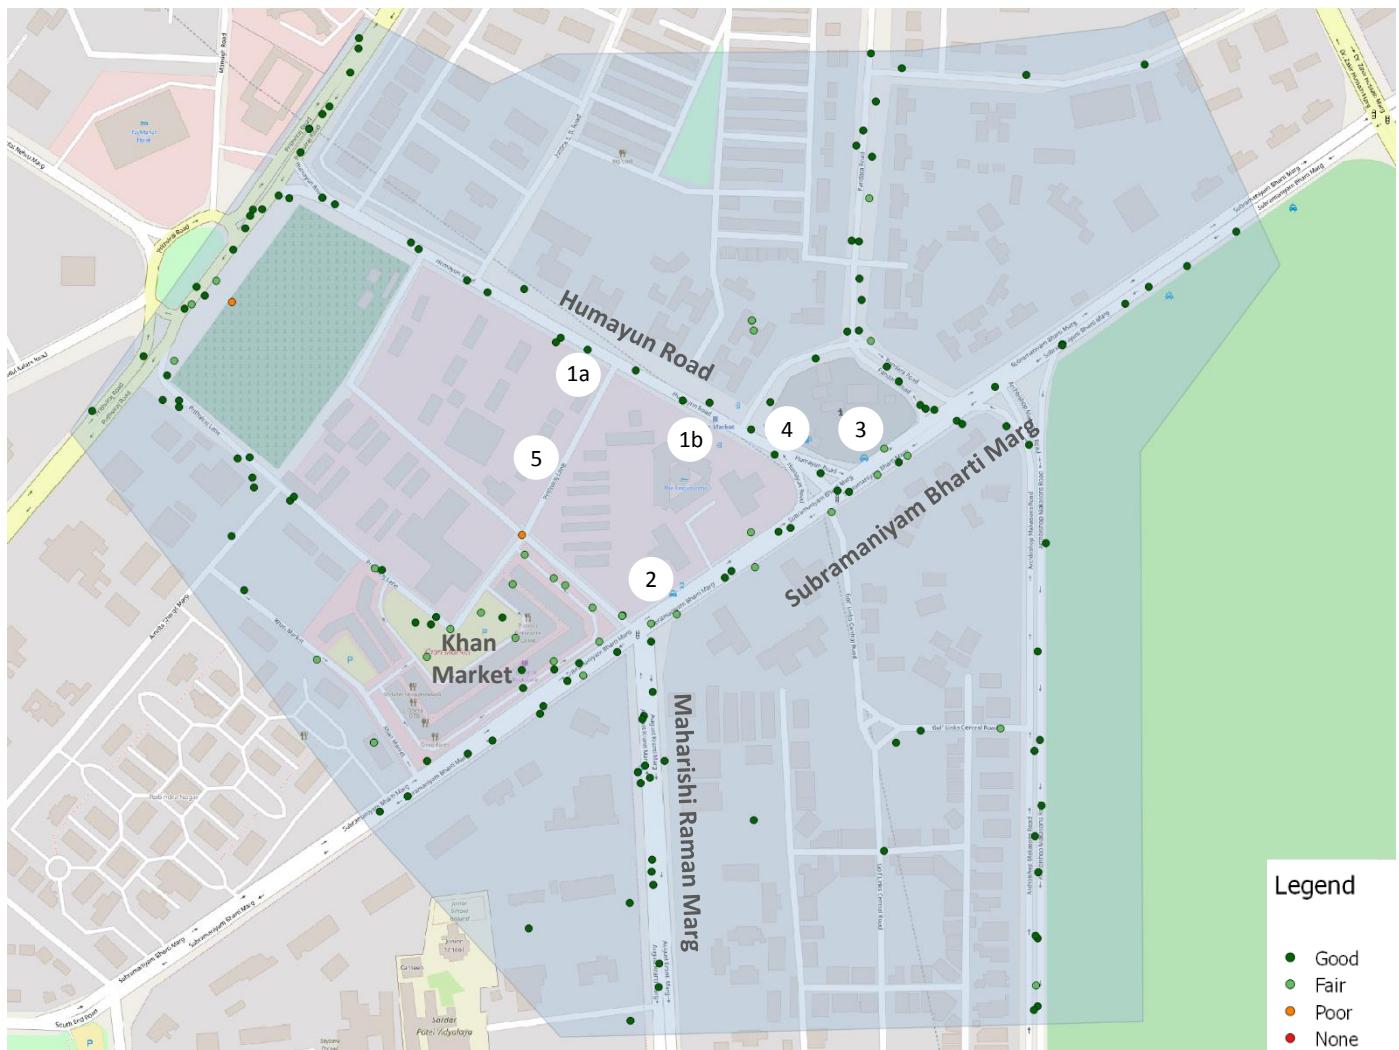
Walkpath Rating

Walkpath Parameter has been rated 2.8/3 i.e. Good. The footpath is well maintained throughout the audit area. However, various types of obstructions were found at some audit points. Streetlights, sign boards, electrical units set up on the footpath obstructs the movement of the pedestrians. The ramps and table top crossing provided at the junctions are also obstructed due to improperly placed sign boards.

The sign boards and streetlights should be placed along the edge of the footpath, thus ensuring smooth movement for the pedestrians including the physically challenged. Another issue found was absence of tactile paving for the visually challenged. Also, the tactile paving provided at the bus stop ends abruptly. The tactile paving should be provided throughout the footpath.

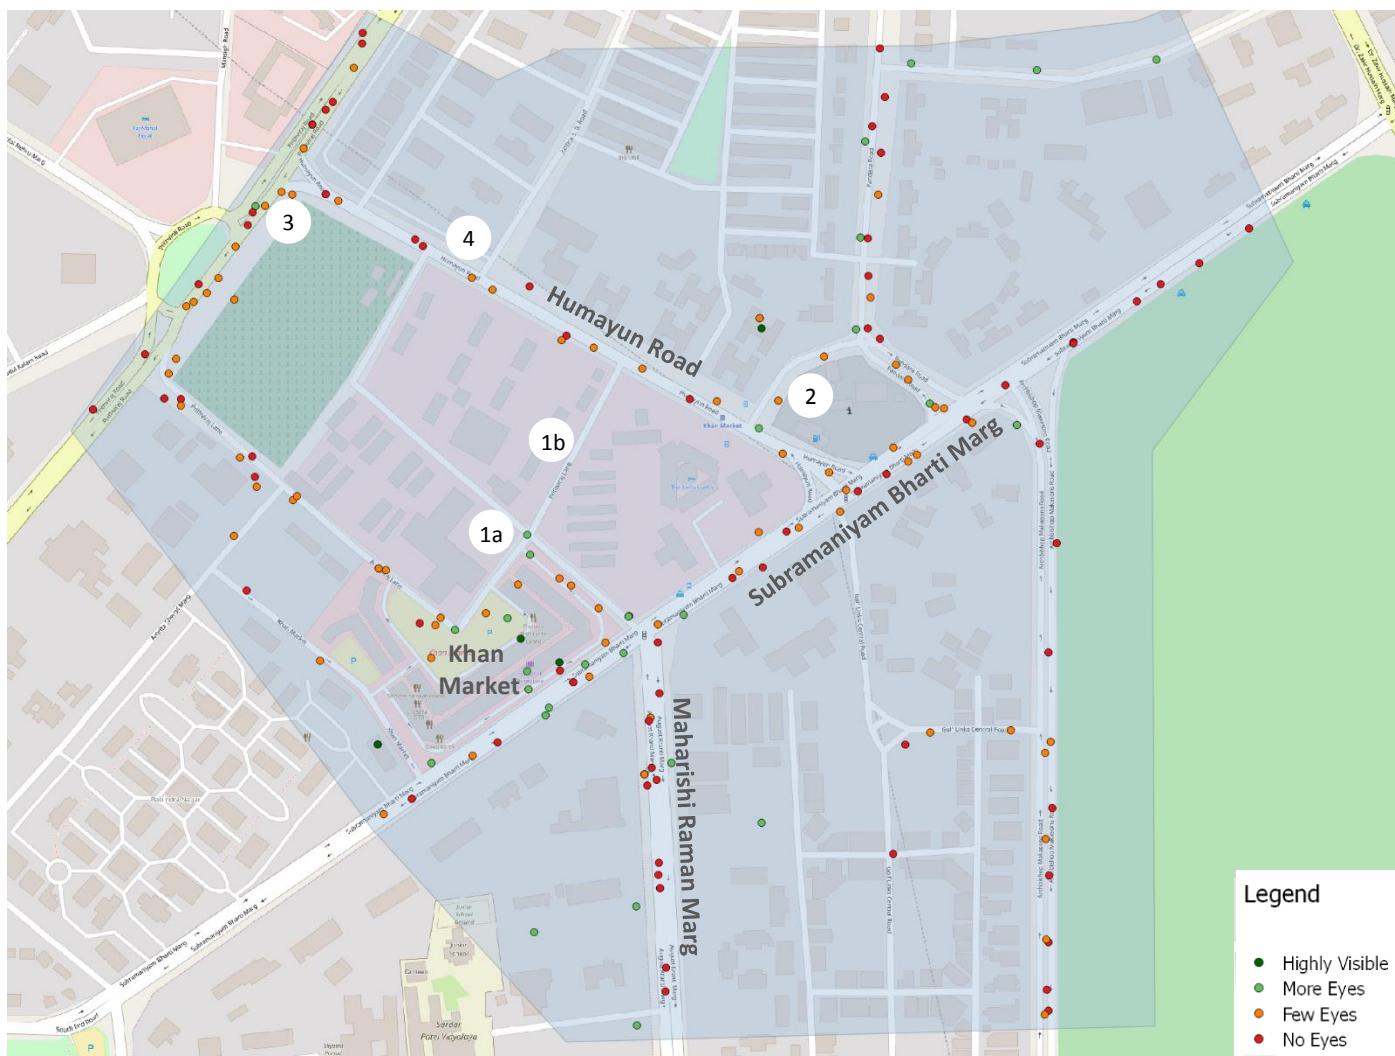
Visibility Rating

Visibility Parameter has been rated 0.8/3 i.e. Below Average. This is due to high boundary walls of the buildings. The height of the solid part of the boundary wall should be maintained at 1 m and the rest of the height could be achieved using grills.

Few kiosks and street vendors present near the bus stop and market respectively, provide some visibility. Designated hawker zones should be set up, clear of the footpath. They should be brightly lit and equipped with street furniture.

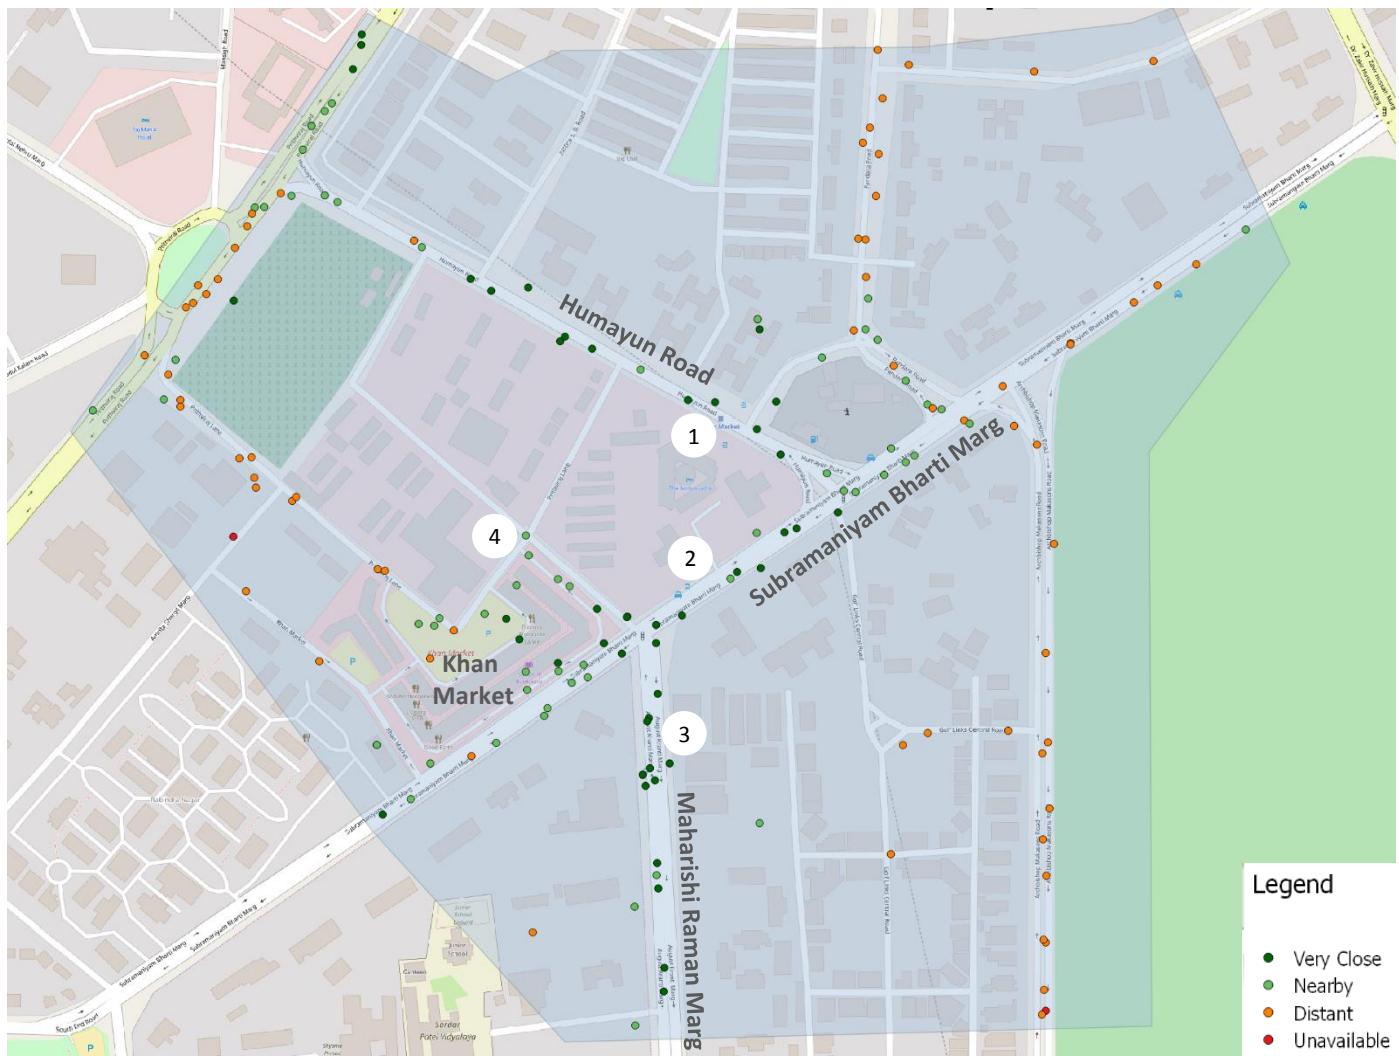
Public Transport Rating

Public Transport Parameter has been rated 1.8/3 i.e. Average. Designated space for autos have been provided near the entry/exit of the metro station. However, similar provision is not provided near the bus stops. Designated stands for autos are needed to be created near the bus stops as well.

Additional para – transit stands should be provided in and around residential neighbourhoods and the market. These stands should be equipped with proper shelter and street furniture for the drivers and commuters.
