My City Initiative Delhi

a project by World Vision India

Safetipin, in collaboration with World Vision India, conducted safety audits in Lalbagh and Madanpur Khadar. The audits were conducted by the volunteers from the local community group supported by World Vision.

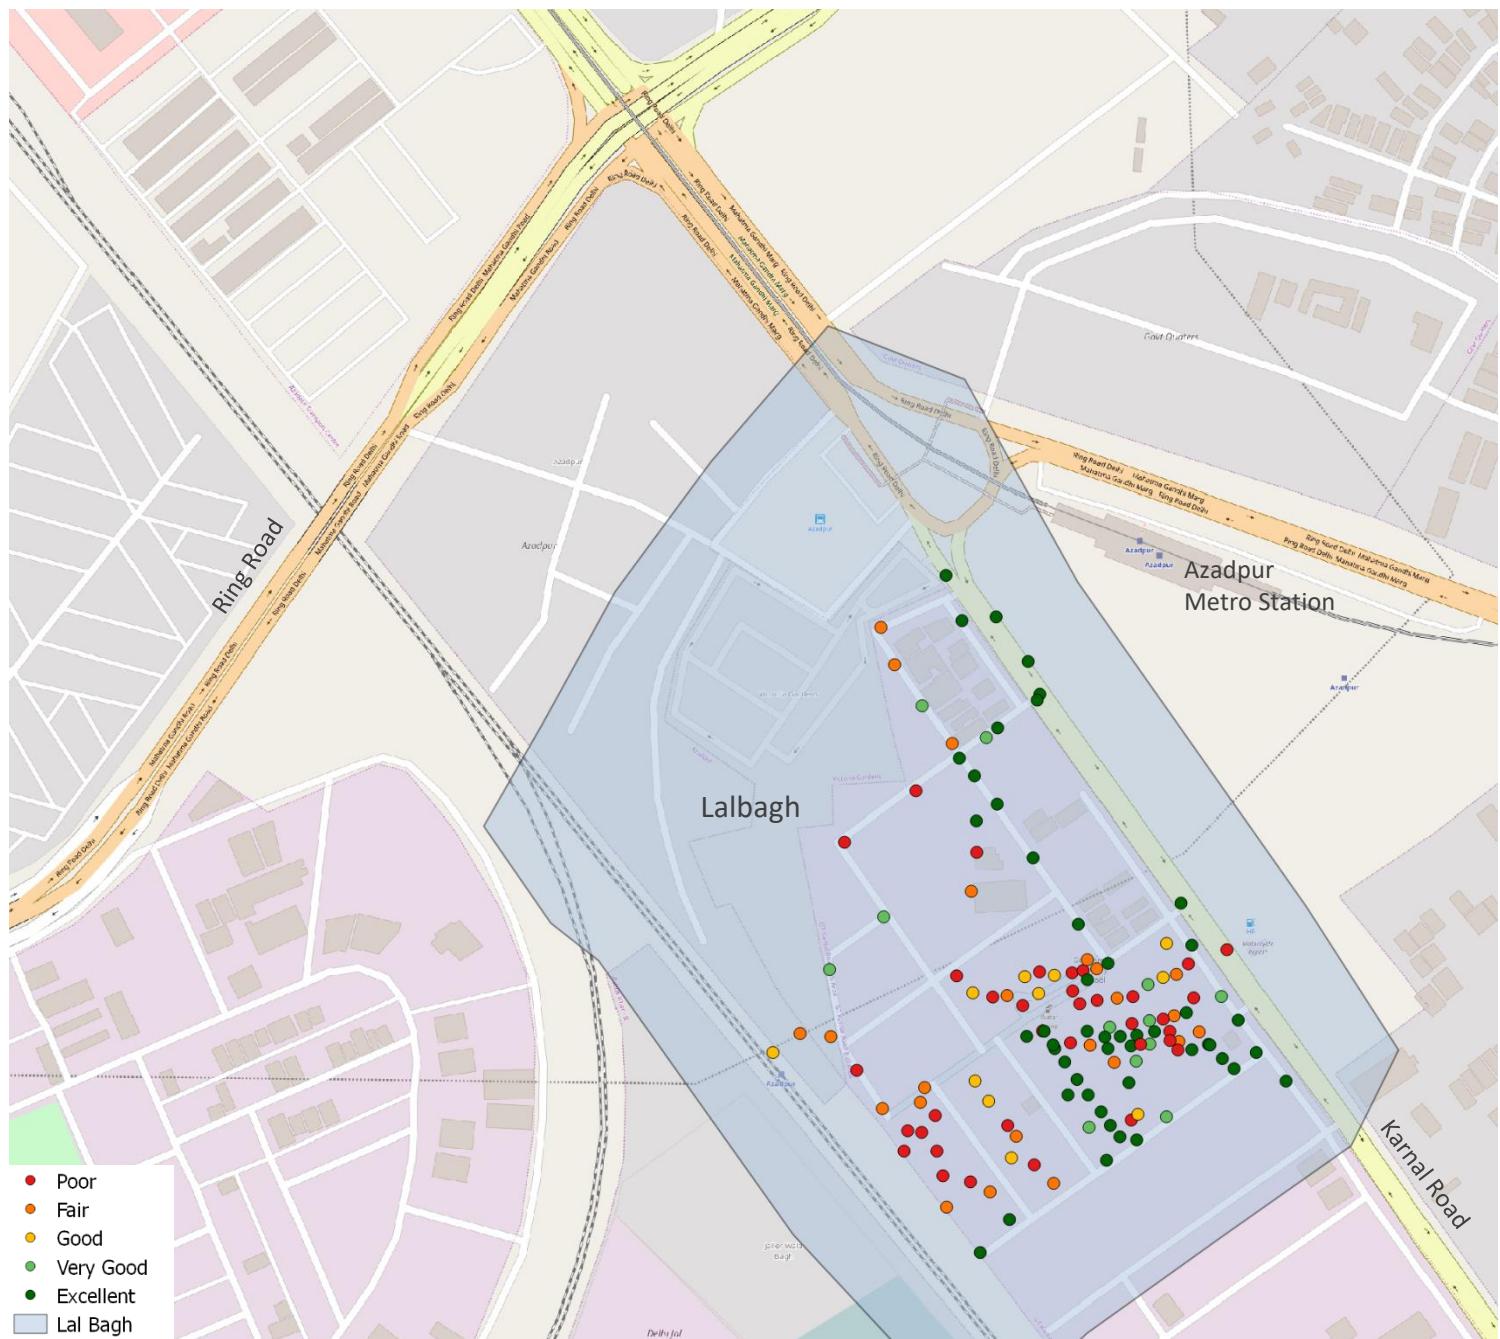
Map indicating Safety Score Rating

The audit ratings of Lalbagh indicate the area offers a mixed feeling of safety i.e. while certain areas are very safe others are very unsafe. The main Karnal Road has been rated safe along with the Lalbagh market street and the street adjoining Blocks A and B. Some of the lanes inside the neighbourhood have been rated as unsafe. Block A (towards the railway track side) has been rated as unsafe.

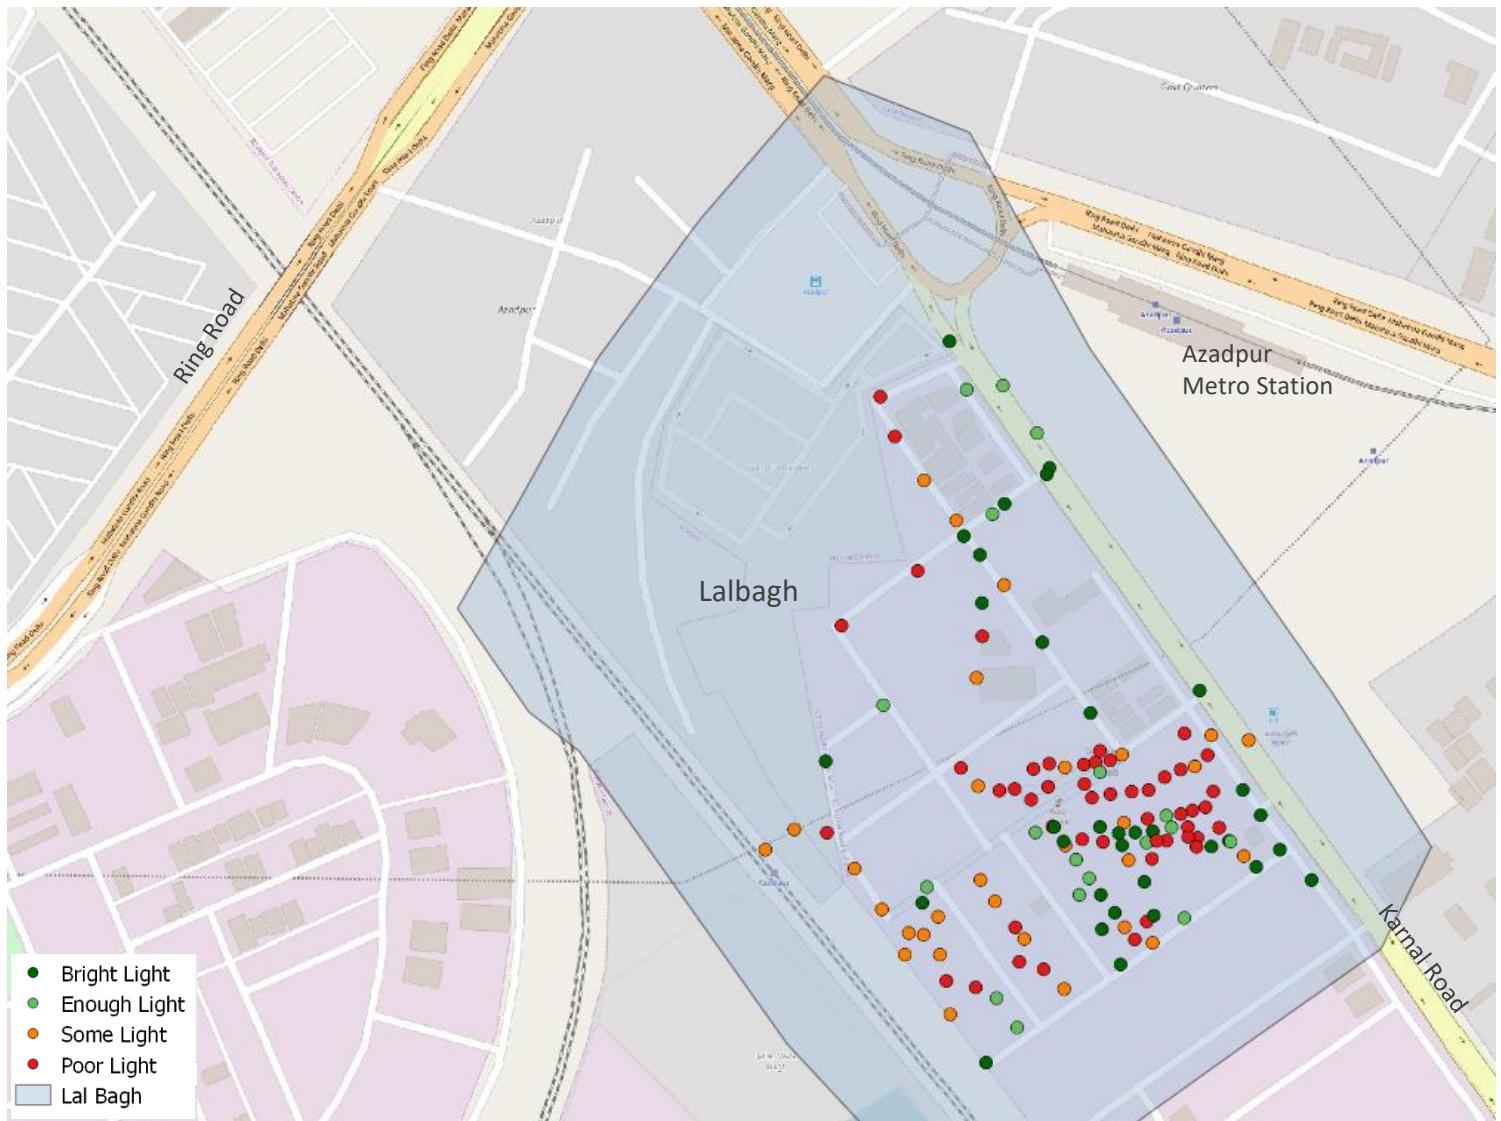
Map indicating Lighting Rating

Lighting parameter has been rated 1.3/3 i.e. Average. The main Karnal Road is adequately lit. The Lalbagh market road is well lit due to the illumination from shops and hawkers. The presence of vendors also helps in otherwise poorly lit areas. Yet many areas were found to be extremely dark making one feel unsafe. Streetlights need to be installed along these areas such as the parking space along M2K Victoria Gardens. In the inner lanes also streetlights need to be installed. Along some lanes the streetlights already exist, however they were found to be un-operational. These need to be regularly maintained to ensure the area is well lit at all times.

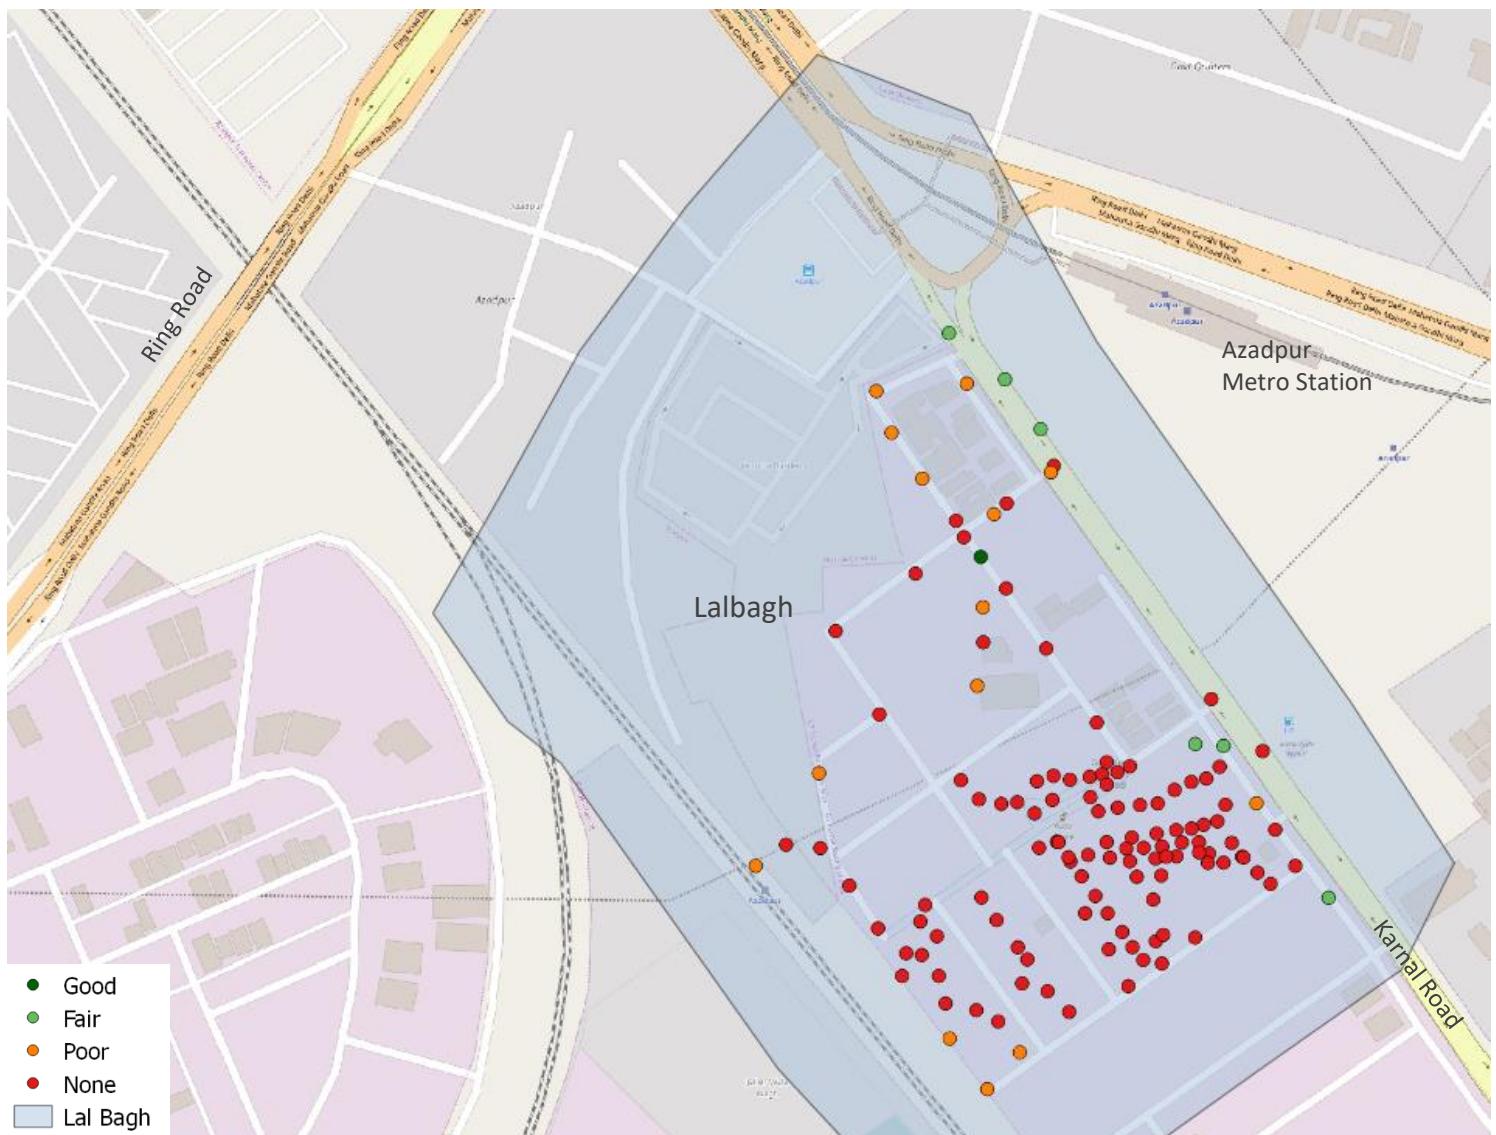
Map indicating Walkpath Rating

Walkpath parameter has been rated 0.2/3 i.e. Poor. Along the main Karnal Road there is a footpath though it is in poor condition along some parts. This needs to be repaired to provide a properly paved surface for people to walk on. Inside the neighbourhood, the main roads are wide but not enough to provide a separate pavement. However, currently due to increased vehicular movement and parking, there is no space for people to walk safely. At many places potholes and open drains were observed. Open drains are also common in the inner narrow lanes. These need to be covered and the drain cover should be flushed with the road surface. Vehicular movement should also be studied and re-worked.

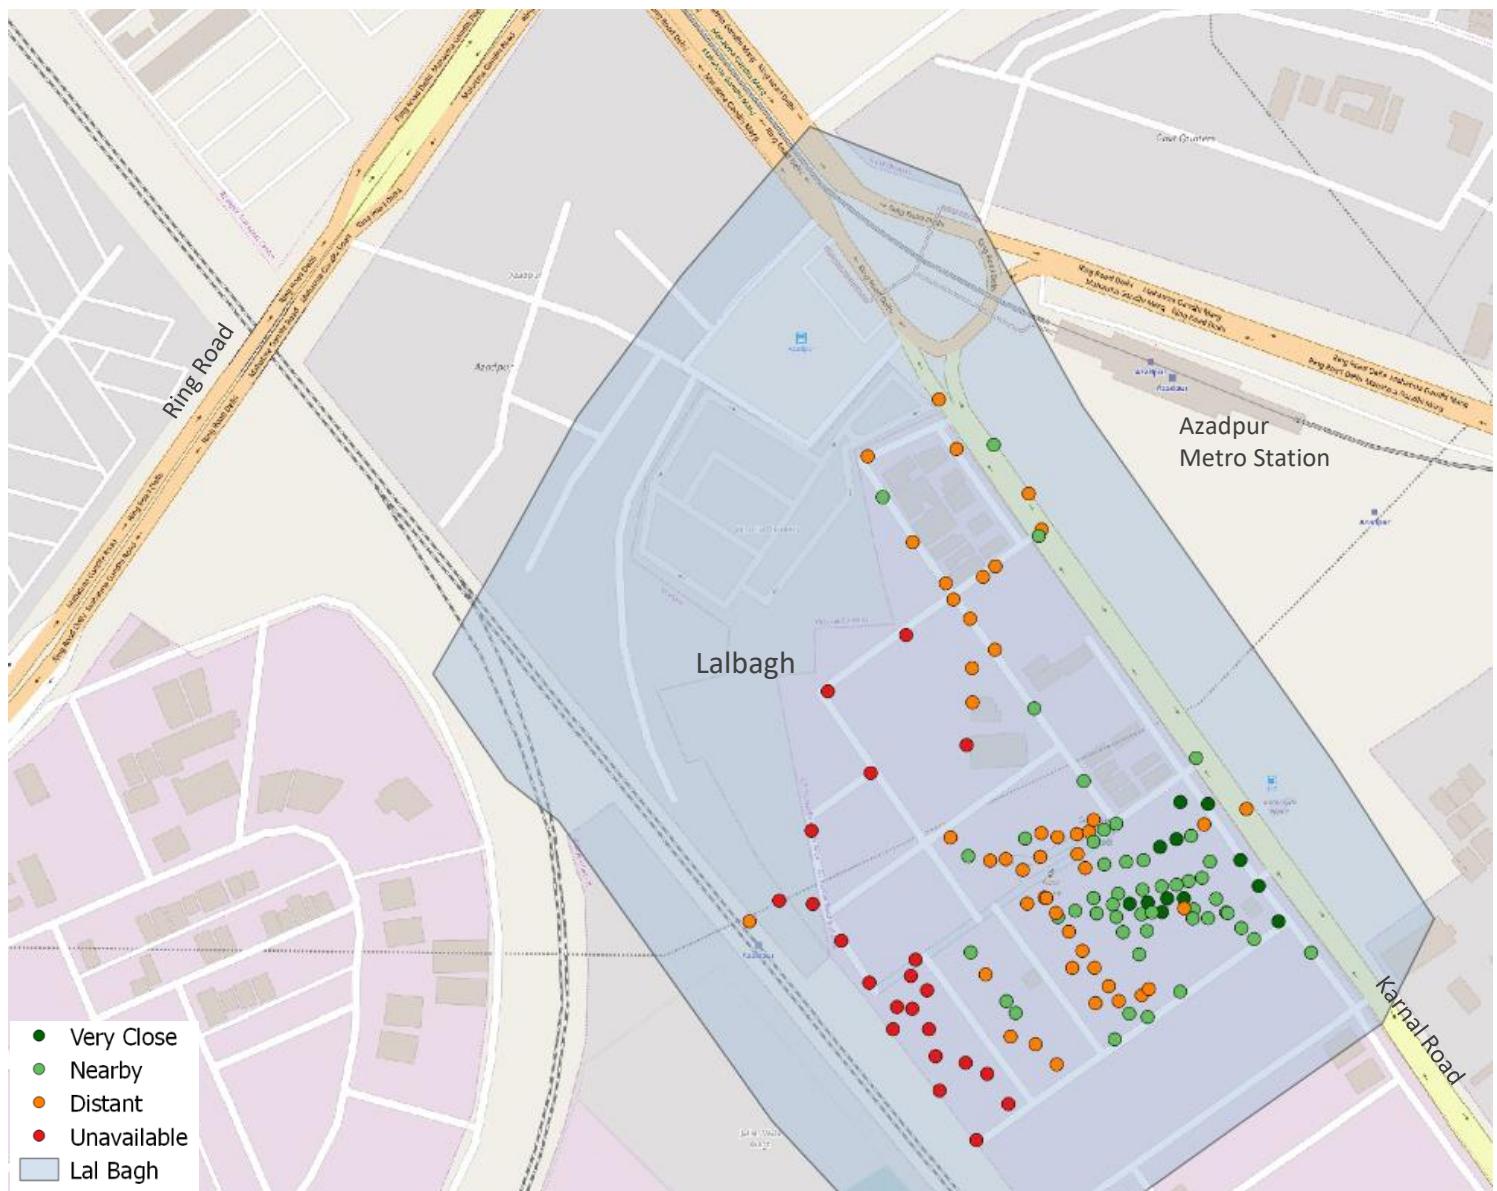
Map indicating Public Transport Rating

Public Transport parameter has been rated 1.4/3 i.e. Average. Autos and e-rickshaws are easily available along the main road and Block-C. But as one moves inside the neighbourhood away from the main road the ease of availing these facilities reduces as there is no dedicated stand or parking area for them. There are certain chowks inside where tempos etc are seen parked. A para-transit stand can be incorporated in such areas. Also as seen in the pics below, a lot of land is wasted on account of uncleared garbage. This space can be efficiently used for other activities.

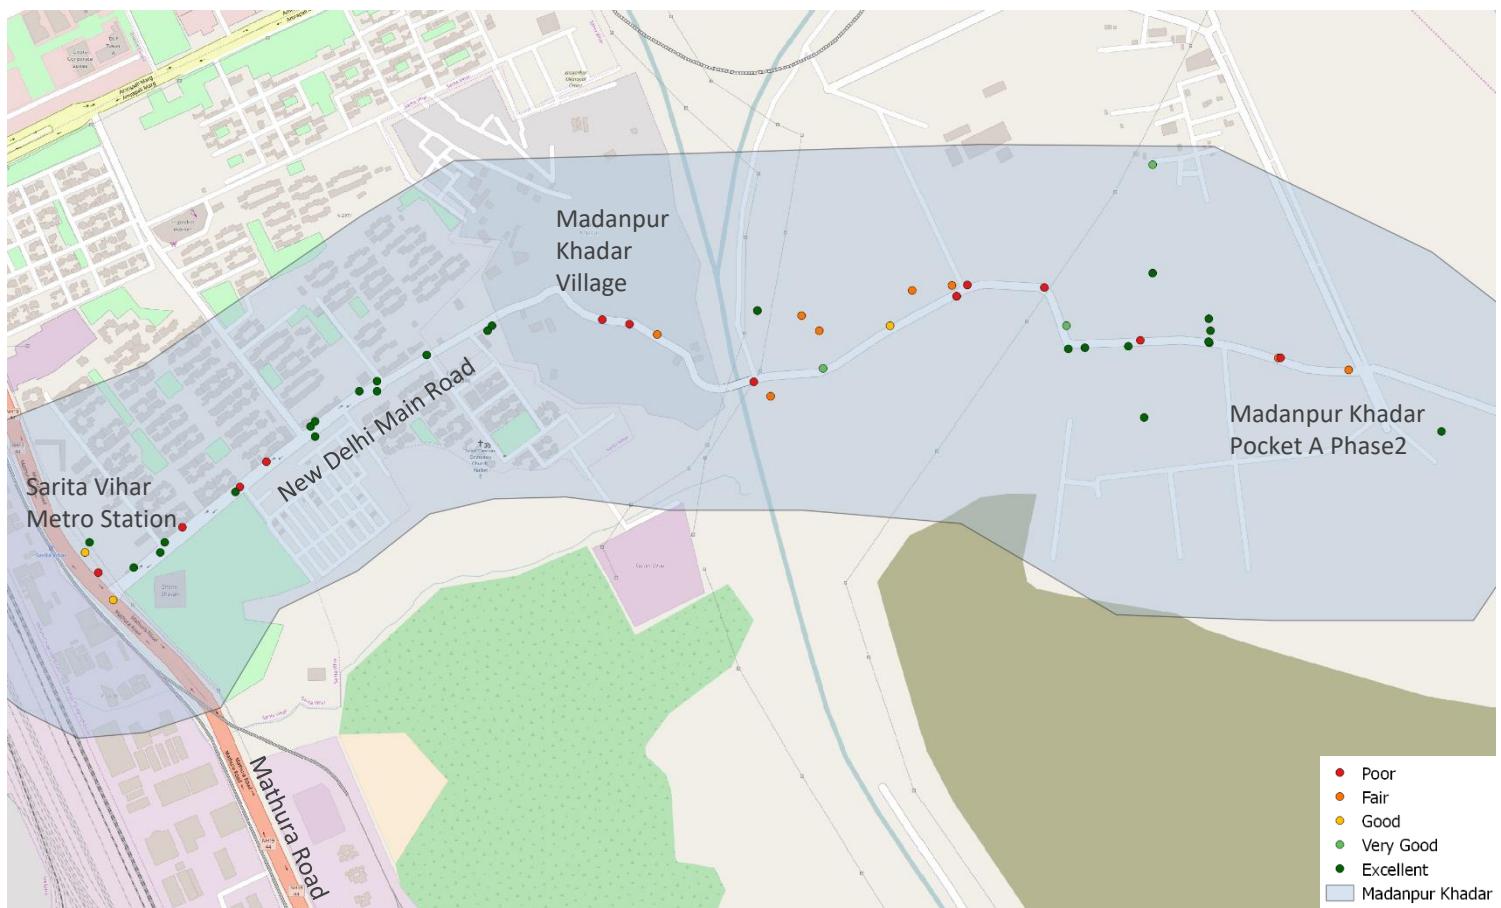
Safety audits of the road indicate that the some part of this stretch is safe i.e. the stretch along the Sarita Vihar residential area. After one crosses this area and move towards the village and then the resettlement colony, the stretch tends to become unsafe. The most unsafe part is along the low-lying open garbage dumping ground. This also has factories and trucks are parked on the road. Due to lack of any other activity and pedestrian movement, this stretch is very unsafe for girls to cross especially at night. The garbage should be cleared regularly such that this area can be developed into a properly landscaped public park. This would encourage people of all age groups and both genders to use it. As a result this stretch would tend to be safer.

In the remaining road length, specific parameters like Lighting and Walkpath need to be improved. Para-transit stands need to be created at regular distances throughout the length of the road and within the residential areas as well. Certain parts have high visibility due to the dense fabric but along the Sarita Vihar residential area, the road edge is defined by blank boundary walls. These edges need to be made porous to ensure visual connectivity. Hawkers zones can also be created at certain areas where the footpath is wide enough.

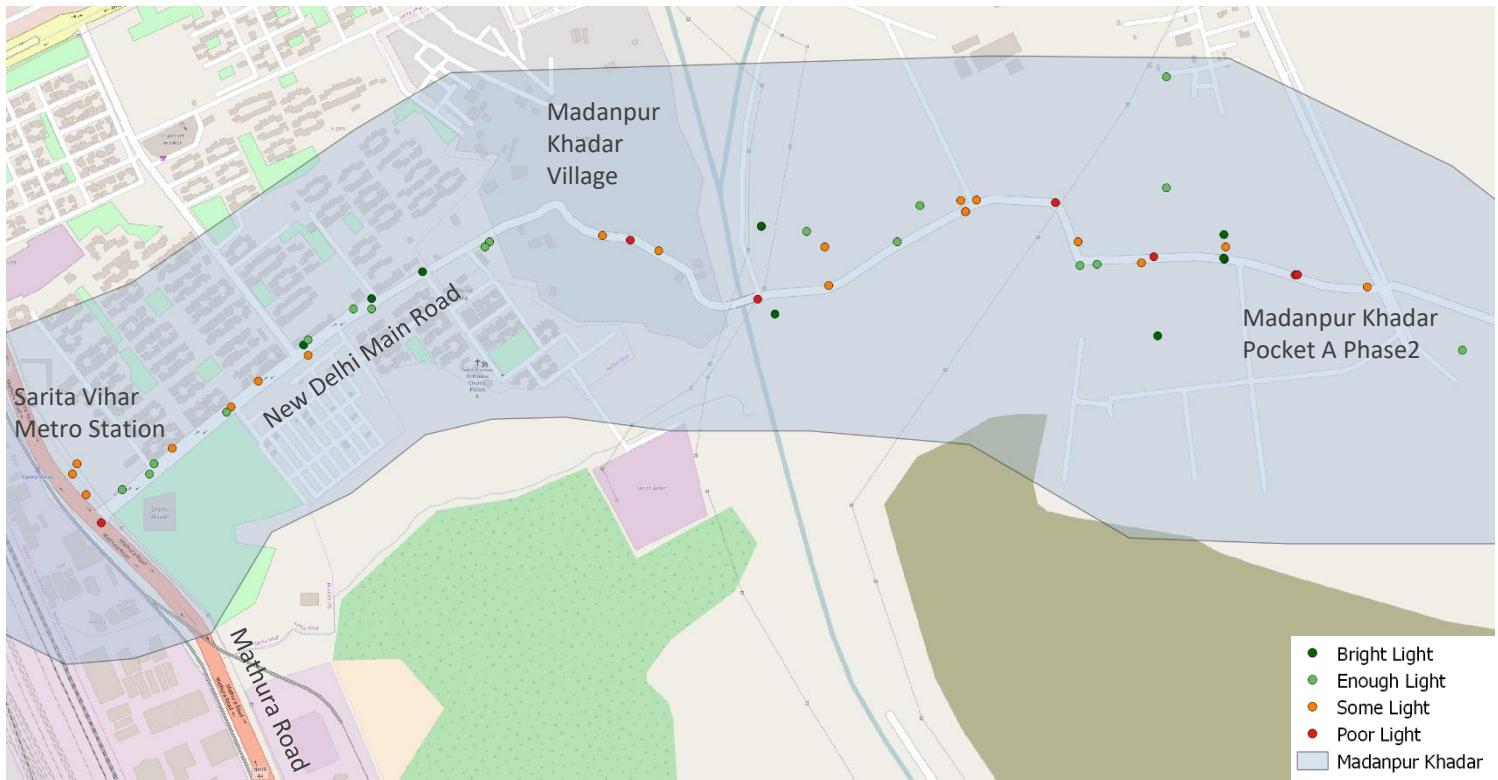
Map indicating Lighting Rating

Lighting parameter has been rated 1.5/3 i.e. Average. Along the Mathura Road streetlights have been located along the central median. As a result the footpath leading to the metro station is poorly lit. Even the area outside the Public Convenience was poorly lit.

Along the Sarita Vihar residential area, certain stretch is lit but some part is poorly lit. Some streetlights were found to be un-operational. Also the light fixture is directed towards the vehicular carriageway while the footpath is not adequately lit.

Along the village the road is poorly lit as the streetlights are very far apart creating dark spots in between.

The road along the low lying area does not have streetlights and becomes very unsafe. In the market areas there is some illumination from both the streetlights and the vendors. But once the market closes the area becomes dimly lit.

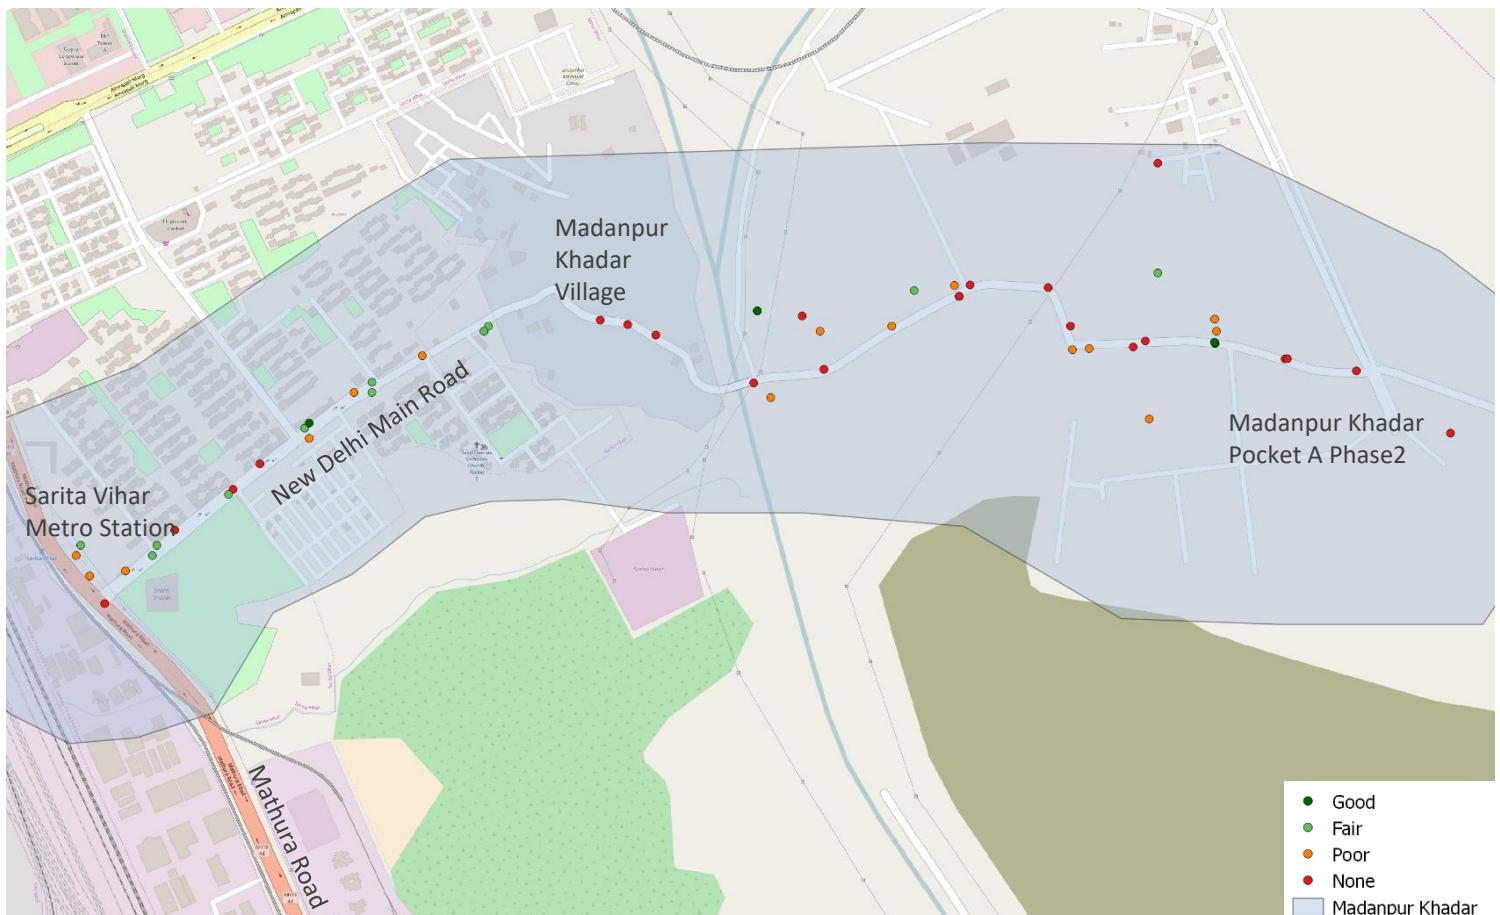
Map indicating Walkpath Rating

Walkpath parameter has been rated 1/3 i.e. Below Average. A good walkable footpath exists only at certain points along the Mathura Road and along the Sarita Vihar area. If the footpath exists then it is either broken or is obstructed by trees or vehicles parked on it. The footpath should be repaired. At points where it is obstructed by a tree, it should be widened. Patrolling and checks should be carried out to prevent vehicles being parked on the pavement.

Along the areas where the road is narrow and a separate pavement cannot be constructed, the road should be well maintained. Dedicated space should be created for hawkers. Houses and shops should not be allowed to extend onto the road as this further reduces the effective width of the road. Along certain parts space has been left for constructing the footpath. This space should be properly paved.
